Damage assessment of autoclaved aerated concrete buildings: some Italian case studies

Damage assessment of autoclaved aerated concrete buildings: some Italian case studies / Ferretti, Daniele; Michelini, Elena; Pongiluppi, Nicola; Cerioni, Roberto. - In: INTERNATIONAL JOURNAL OF MASONRY RESEARCH AND INNOVATION. - ISSN 2056-9459. - 5:1(2020), pp. 279-301. [10.1504/IJMRI.2020.10024371]

1 **Damage assessment of autoclaved aerated concrete**
2 **buildings: some Italian case studies**

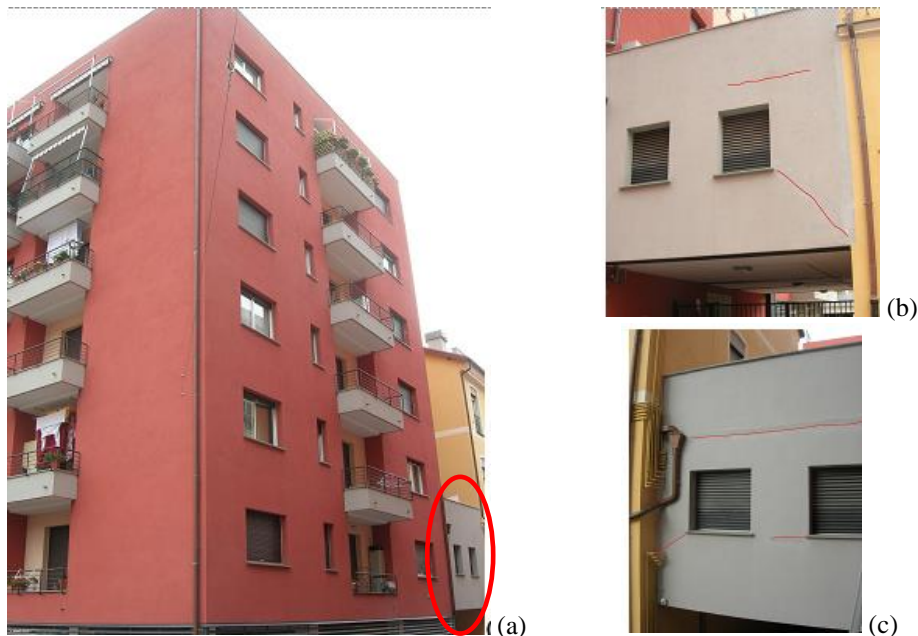
142 An example of cracking in AAC masonry walls due to the deformability of the floor
143 lying under the walls themselves is shown in Figure 1. The examined case study is
144 located in Genova and is characterized by the presence of a suspended gallery made of
145 bearing AAC masonry, which connects two buildings with different high (Figure 1a).

147 **Figure 1** Example of cracks in AAC walls due to floor deflections: (a) general view of
148 the suspended gallery between two buildings in Genova, and observed crack pattern in its
149 (a) front and (b) rear sides.

151 As can be seen, the deflection of the floor determined the appearance of tensile
152 stresses both in the front and the rear walls of the gallery, and the observed damage seems
153 to indicate a possible formation of an arch-shaped crack. Figures 1b-c show the upper part
154 of the arch, with an almost horizontal crack placed over the two openings, and the bottom
155 part of the arch, with an approximately 45-deg inclined crack connecting the bottom part
156 of the opening with the wall side.

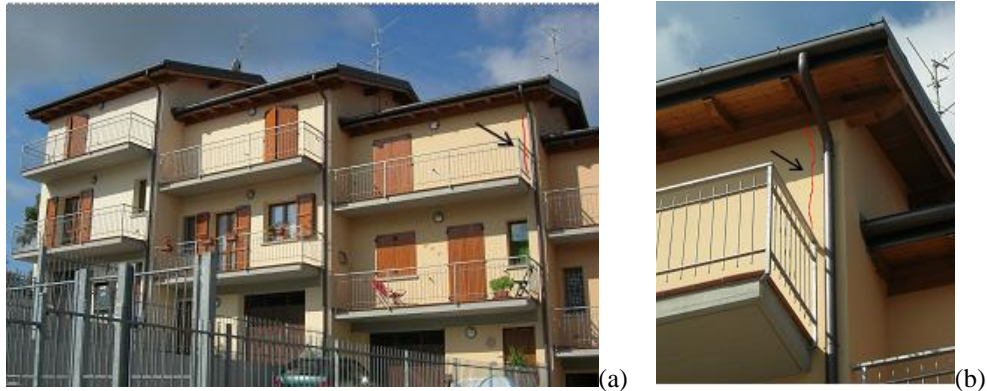
157 Another example of a typical damage due to static loads that can be observed in AAC
158 masonry bearing walls is reported in Figure 2, which shows a terraced house in Bologna.
159 In this case, the crack pattern is characterized by the presence of an almost vertical crack
160 at the upper level of the third housing unit, at the connection zone between two
161 perpendicular walls. This type of crack often appears when the two walls are differently

162 loaded, which is a quite common situation in civil engineering, due to the presence of
163 one-way floors and roofs.

165 **Figure 2** Example of cracks in AAC masonry walls due to static loads (terraced house in
166 Bologna).

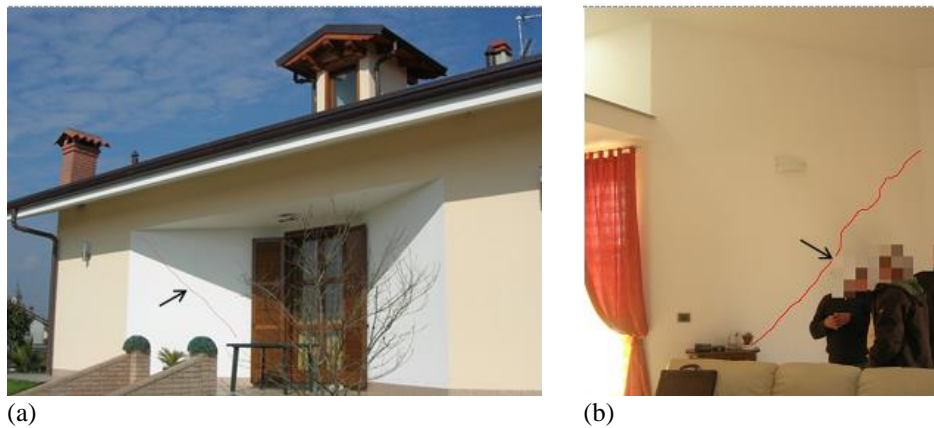
168 **Figure 3** Example of cracks in AAC walls due to static loads (detached house in Novara).

176 Finally, an example of crack pattern mainly attributable to differential soil settlements
177 is reported in Figure 3, for an AAC masonry building located in Novara. In this case, the
178 differential settlements of the soil under the residential house produced the appearance of
179 tensile stresses in the inclined wall belonging to the building front, near the main
180 entrance. This stress field caused in turn the formation of a typical diagonal crack, almost
181 inclined at 45-deg and interesting the whole thickness of the wall.

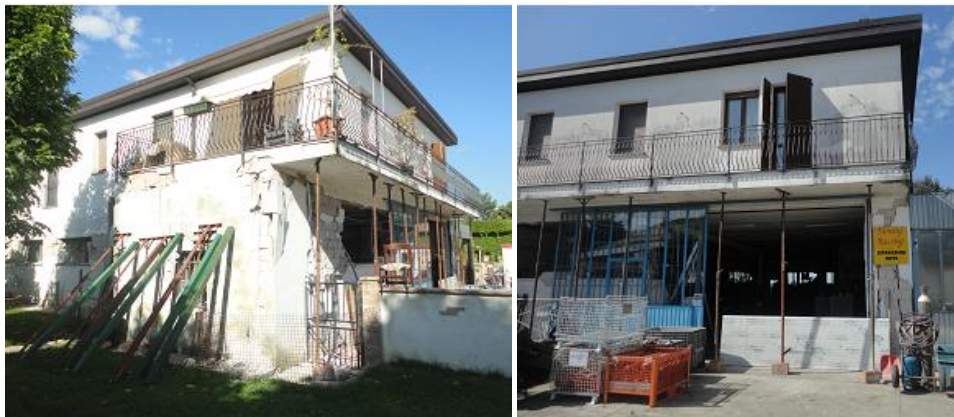
247 **Figure 6** House in San Possidonio: (a), (b) general view of the building and of the
248 external damages caused by the Emilia's earthquake.

258 During the Emilia's earthquake, the building was subjected to a maximum PGA of
259 0.33g (see Figure 5a) that caused heavy damages to the masonry, as shown in Figures 6
260 and 8-9. The behaviour was mainly governed by the in-plane wall response, even if some
261 portions of the external walls undergone local out-of-plane collapses (see Figure 8b, over
262 the opening on the right). Diagonal shear cracks in masonry piers of the ground floor,
263 together with crushing phenomena can be recognized in Figures 6, 8 and 9. This
264 widespread damage was the consequence of some deficiencies in the structural
265 conception of the building, which was not designed for seismic resistance, but only for
266 carrying vertical loads. The main element of vulnerability was represented by the lack of
267 a sufficient amount of walls along the two main directions, which was respectively equal
268 to about 2% and 2.6% of the floor gross area. This insufficient “wall density” caused the

269 appearance of high stress levels on the piers at the ground storey, leading to a reduced in-
270 plane deformation capacity for shear mechanisms.

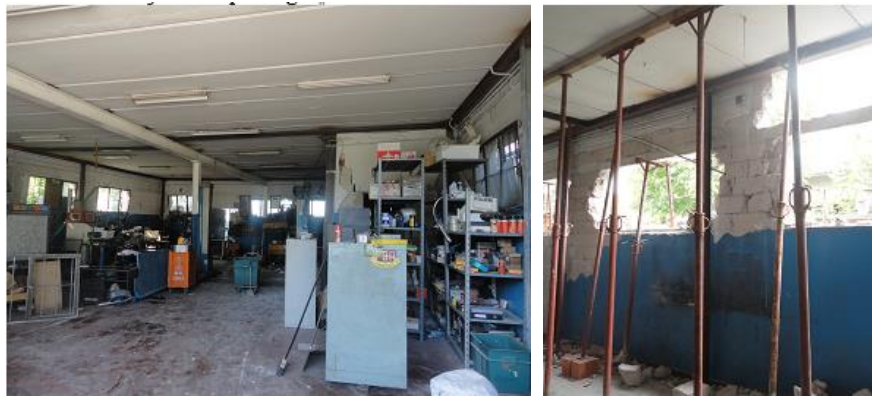
Figure 8 (a) Internal view of groundfloor and (b) detail of diagonal cracks in masonry piers between adjacent openings.

This problem was further increased by the large distance between the bearing walls sustaining the horizontal forces (respectively equal to 12 and 17 m in the main directions, Figure 7), the relatively small thickness of the walls (250 mm), and the presence of large openings, with the consequent formation of squat masonry piers (i.e. Figure 8). Finally, Figure 9a shows the crack pattern registered at the connection zone between two perpendicular walls, near the stairs' door. From Figure 9b, it can be also seen that remarkable masonry disruption took place in AAC walls. This fact explains the rising

287 interest of the scientific and technical community in studying the application of several
288 reinforcement techniques (mainly meshes or trusses) to increase wall ductility.

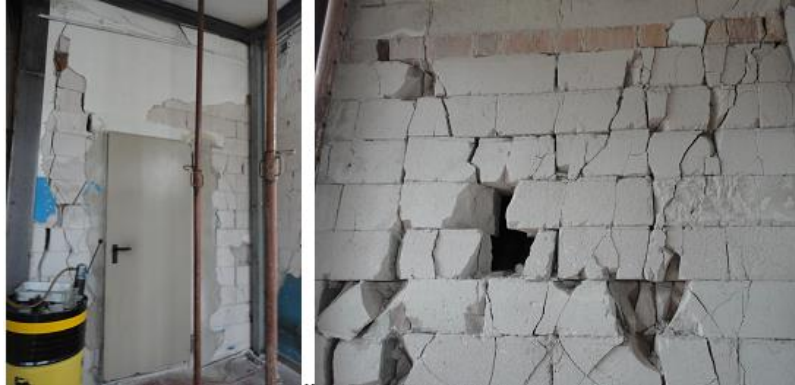
290 **Figure 9** (a) Crack pattern at the connection zone between perpendicular walls and (b)
291 diagonal cracks in a masonry pier.

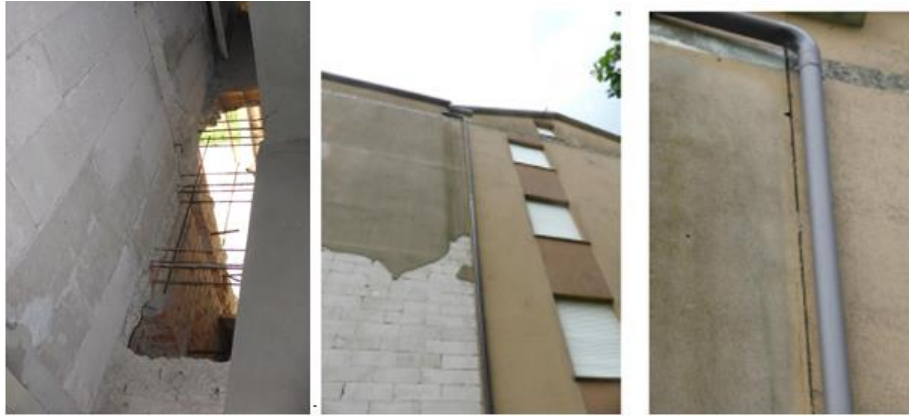
313 This new part was made of 250 mm thick AAC masonry with a density almost equal
314 to 5 kN/m^3 , except for the ground storey, which was built again with solid bricks (as can
315 be seen in Figure 12a). Inter-storey floors were similar to those adopted in the older part
316 of the building, but a flat roof was chosen in this case (see Figure 10a). The connection
317 between the two adjacent parts was not realized according to good practice rules and
318 several localized detachment of plaster took place during the earthquake, due to the
319 relative movements of the two parts (Figures 12b,c).

328 **Figure 12** (a) Presence of solid clay bricks at the ground level of the newest part of the
329 building, under AAC masonry; (b), (c) general view and detail of the connection between
330 the two parts of the building realized at different times.

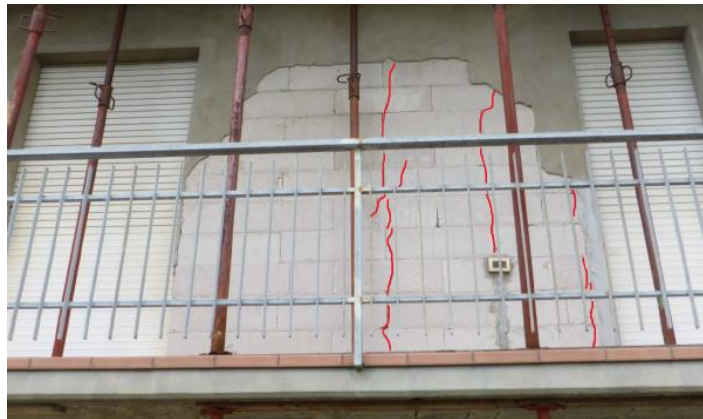
320 The most significant damages undergone by the building during the seismic shakes
321 were concentrated in the newest part of the building, and are depicted in Figures 13 and
322 14. The maximum attained PGA was also in this case equal to $0.33g$, according to Figure
323 5a. The crack pattern was mainly constituted by sub-vertical cracks, together with
324 crushing phenomena and detachment of large portions of plaster. These damages were
325 primarily localised at the first floor (which is the lower one made of AAC), both at the
326 connection zone between two perpendicular walls and in the masonry piers between two
327 openings.

333 **Figure 13** Plaster detachment and sub-vertical cracking in AAC masonry at the first level
334 of the building.

337 This type of cracks is quite common in slender piers subjected to not negligible
338 compressive stresses and has been also observed in laboratory tests, like those carried out
339 by Rosti et al. (2016). The existence of quite large vertical compressive stresses, which
340 were due to the relatively high number of storey and to the limited ratio between walls
341 and floor area, reduced indeed the displacement capacity of the masonry, so leading to a
342 premature failure. This problem was further worsened by the presence of garage
343 entrances at the ground floor, which further reduced the extension of masonry piers. To a
344 certain extent, it is also possible that the observed failure mode had been influenced by
345 the lack of mortar in vertical joints and by the fact that a common mortar for brick
346 masonry, instead of the specific mortar/glue for AAC, was used for the filling of bed
347 joints.

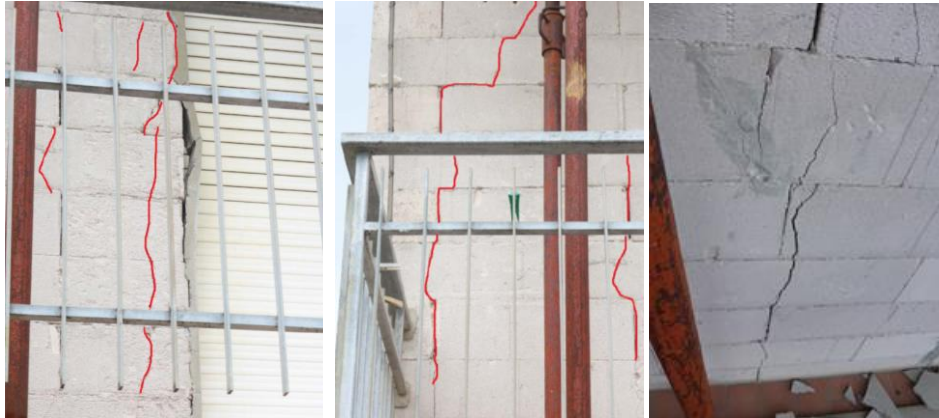
349 **Figure 14** Details of sub-vertical cracks in the AAC masonry of the rear façade of the
350 building, behind the balconies: (a) near an opening; (b) near the connection between two
351 perpendicular walls; (c) in the central part of a masonry pier.

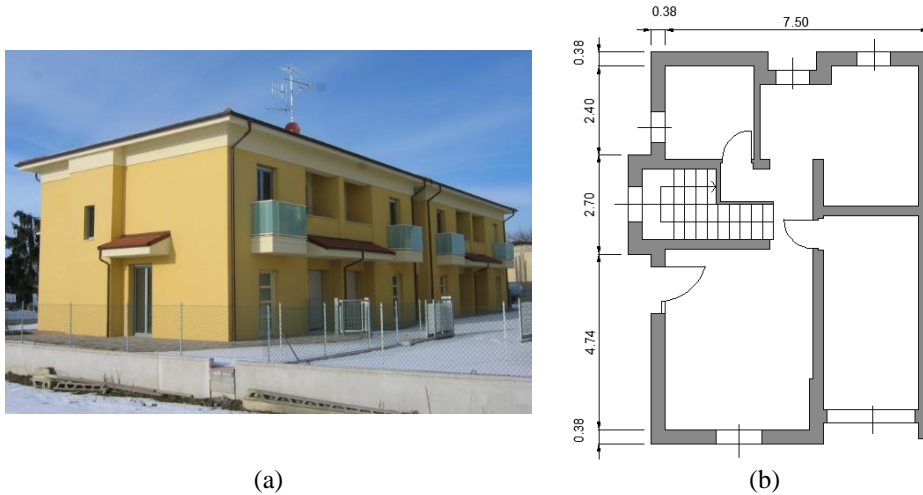
370 The post-earthquake inspection survey did not reveal the presence of any cracks and
371 damages nor in the peripheral nor in the internal walls. In any case, it should be observed
372 that the building was subjected to a relatively low seismic action, since the reference peak
373 ground acceleration prescribed for that area by the actual Italian Standard Code is 0.21g.
374

375 **Figure 16** (a) Detail of one building belonging to the residential complex of Altedo; (b)
376 plan of the ground floor of one housing unit.

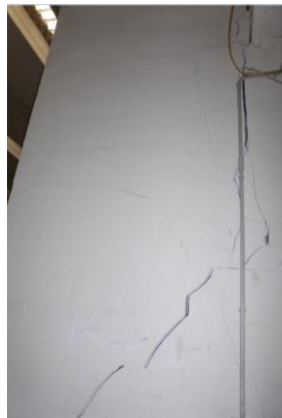
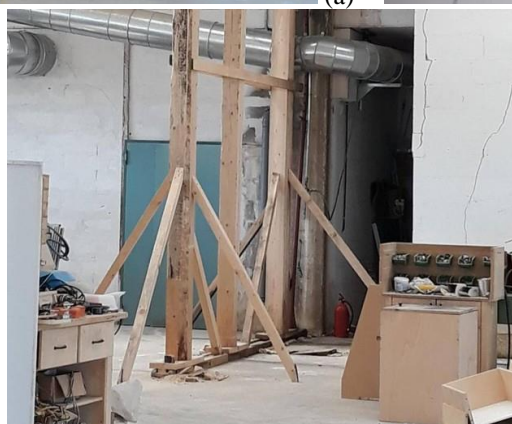
440 **Figure 22** (a) Internal view of the furniture factory in Muccia; (b), (c) crack pattern in
441 AAC masonry partitions.

450 AAC masonry partitions presented diffused shear cracks (Figures 22b,c), probably
451 because of the remarkable deformability of the RC structure and the consequent
452 interaction with non-structural walls. This type of damage was documented also in the
453 industrial precast buildings after the Emilia 2012 earthquake, regardless of masonry
454 typology (Savoia et al., 2017).
