Damage assessment of autoclaved aerated concrete buildings: some Italian case studies

Damage assessment of autoclaved aerated concrete buildings: some Italian case studies / Ferretti, Daniele; Michelini, Elena; Pongiluppi, Nicola; Cerioni, Roberto. - In: INTERNATIONAL JOURNAL OF MASONRY RESEARCH AND INNOVATION. - ISSN 2056-9459. - 5:1(2020), pp. 279-301. [10.1504/IJMRI.2020.10024371]

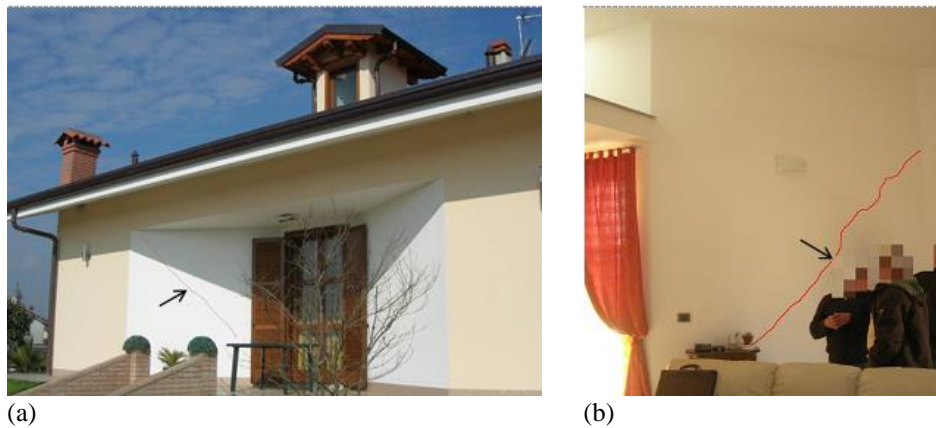
168 **Figure 3** Example of cracks in AAC walls due to static loads (detached house in Novara).

176 Finally, an example of crack pattern mainly attributable to differential soil settlements
177 is reported in Figure 3, for an AAC masonry building located in Novara. In this case, the
178 differential settlements of the soil under the residential house produced the appearance of
179 tensile stresses in the inclined wall belonging to the building front, near the main
180 entrance. This stress field caused in turn the formation of a typical diagonal crack, almost
181 inclined at 45-deg and interesting the whole thickness of the wall.

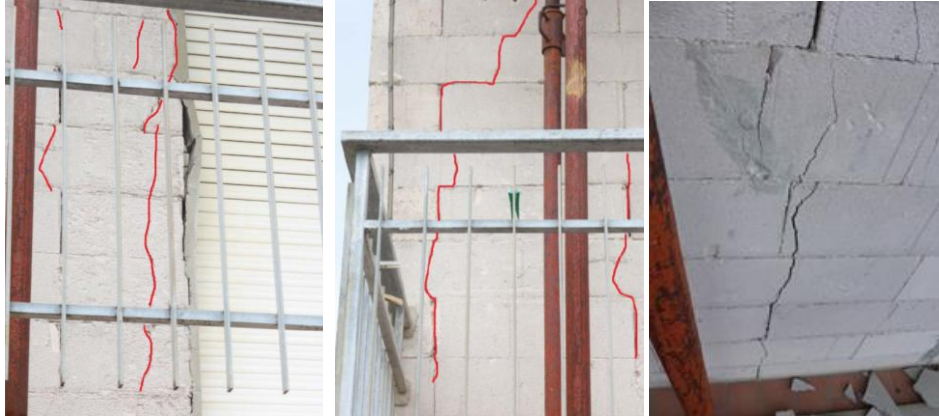
337 This type of cracks is quite common in slender piers subjected to not negligible
338 compressive stresses and has been also observed in laboratory tests, like those carried out
339 by Rosti et al. (2016). The existence of quite large vertical compressive stresses, which
340 were due to the relatively high number of storey and to the limited ratio between walls
341 and floor area, reduced indeed the displacement capacity of the masonry, so leading to a
342 premature failure. This problem was further worsened by the presence of garage
343 entrances at the ground floor, which further reduced the extension of masonry piers. To a
344 certain extent, it is also possible that the observed failure mode had been influenced by
345 the lack of mortar in vertical joints and by the fact that a common mortar for brick
346 masonry, instead of the specific mortar/glue for AAC, was used for the filling of bed
347 joints.

349 **Figure 14** Details of sub-vertical cracks in the AAC masonry of the rear façade of the
350 building, behind the balconies: (a) near an opening; (b) near the connection between two
351 perpendicular walls; (c) in the central part of a masonry pier.

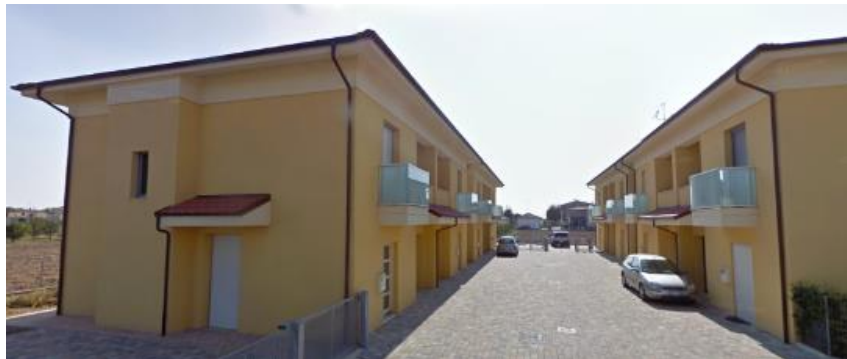
362 **Figure 15** Residential complex made of unreinforced AAC masonry in Altedo (Bologna).

370 The post-earthquake inspection survey did not reveal the presence of any cracks and
371 damages nor in the peripheral nor in the internal walls. In any case, it should be observed
372 that the building was subjected to a relatively low seismic action, since the reference peak
373 ground acceleration prescribed for that area by the actual Italian Standard Code is 0.21g.
374
