Damage assessment of autoclaved aerated concrete buildings: some Italian case studies

Damage assessment of autoclaved aerated concrete buildings: some Italian case studies / Ferretti, Daniele; Michelini, Elena; Pongiluppi, Nicola; Cerioni, Roberto. - In: INTERNATIONAL JOURNAL OF MASONRY RESEARCH AND INNOVATION. - ISSN 2056-9459. - 5:1(2020), pp. 279-301. [10.1504/IJMRI.2020.10024371]

Abstract: The present work deals with the damage assessment of some Italian 14 case studies of structures/walls realized in autoclaved aerated concrete (AAC) 15 16 blocks. Initially, examples of static damage of walls caused by excessive deformability of the slabs, differential loads on walls, and foundation 17 18 settlements, are shown. Then, the seismic behaviour of AAC masonry buildings 19 is analysed. In particular, the behaviour of two pre-seismic code buildings 20 damaged by the Emilia 2012 earthquake is described and compared with 21 modern engineered buildings. Then, the behaviour of non-structural walls damaged by the Central Italy 2016 earthquake is reported. Very few case 22 23 studies focusing on the damage assessment of AAC masonry buildings during real seismic events can be found in the

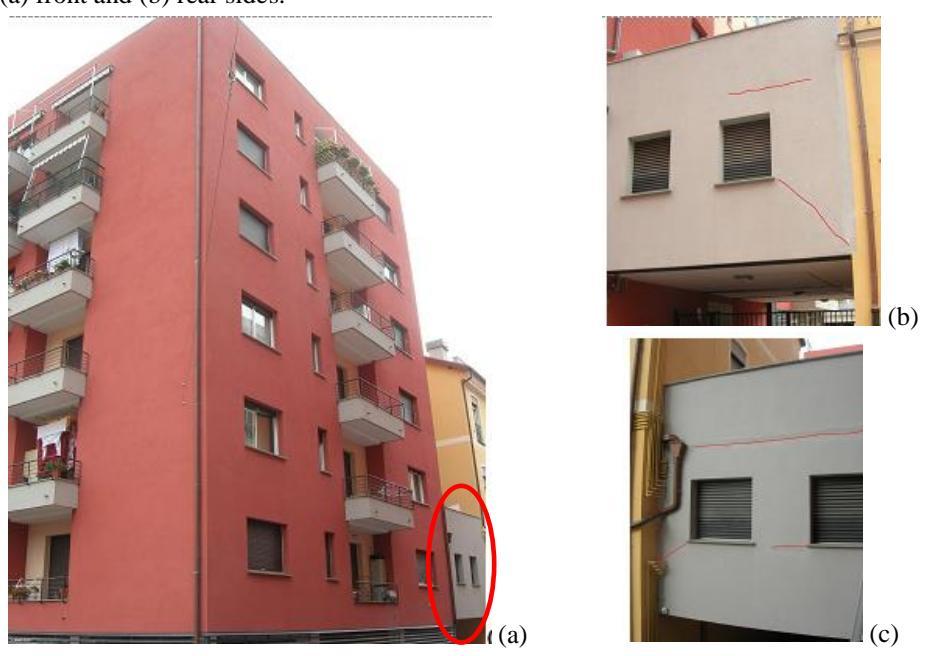
An example of cracking in AAC masonry walls due to the deformability of the floor lying under the walls themselves is shown in Figure 1. The examined case study is located in Genova and is characterized by the presence of a suspended gallery made of bearing AAC masonry, which connects two buildings with different high (Figure 1a).

Figure 1 Example of cracks in AAC walls due to floor deflections: (a) general view of
the suspended gallery between two buildings in Genova, and observed crack pattern in its
(a) front and (b) rear sides.

As can be seen, the deflection of the floor determined the appearance of tensile stresses both in the front and the rear walls of the gallery, and the observed damage seems to indicate a possible formation of an arch-shaped crack. Figures 1b-c show the upper part of the arch, with an almost horizontal crack placed over the two openings, and the bottom part of the arch, with an approximately 45-deg inclined crack connecting the bottom part of the opening with the wall side.

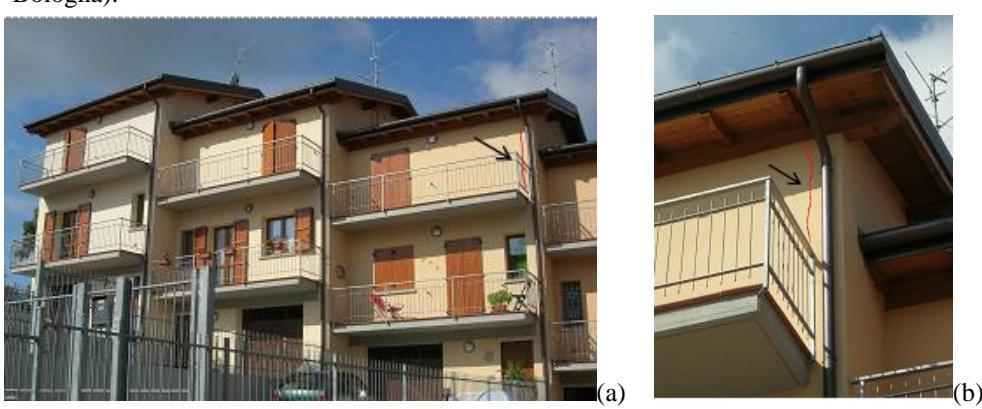
Another example of a typical damage due to static loads that can be observed in AAC masonry bearing walls is reported in Figure 2, which shows a terraced house in Bologna. In this case, the crack pattern is characterized by the presence of an almost vertical crack at the upper level of the third housing unit, at the connection zone between two perpendicular walls. This type of crack often appears when the two walls are differently

- loaded, which is a quite common situation in civil engineering, due to the presence of 162 one-way floors and roofs.
- 163
- 164

Figure 2 Example of cracks in AAC masonry walls due to static loads (terraced house in 165 Bologna). 166

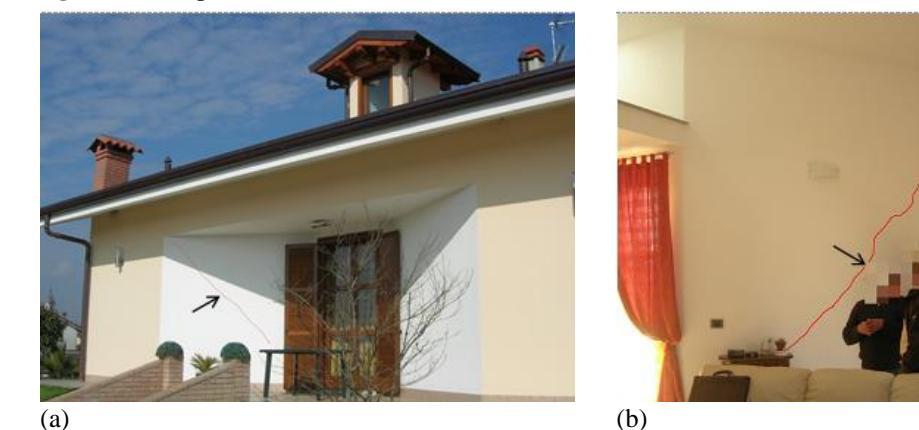
Figure 3 Example of cracks in AAC walls due to static loads (detached house in Novara).

Finally, an example of crack pattern mainly attributable to differential soil settlements 176 is reported in Figure 3, for an AAC masonry building located in Novara. In this case, the 177 differential settlements of the soil under the residential house produced the appearance of 178 tensile stresses in the inclined wall belonging to the building front, near the main 179 180 entrance. This stress field caused in turn the formation of a typical diagonal crack, almost 181 inclined at 45-deg and interesting the whole thickness of the wall.

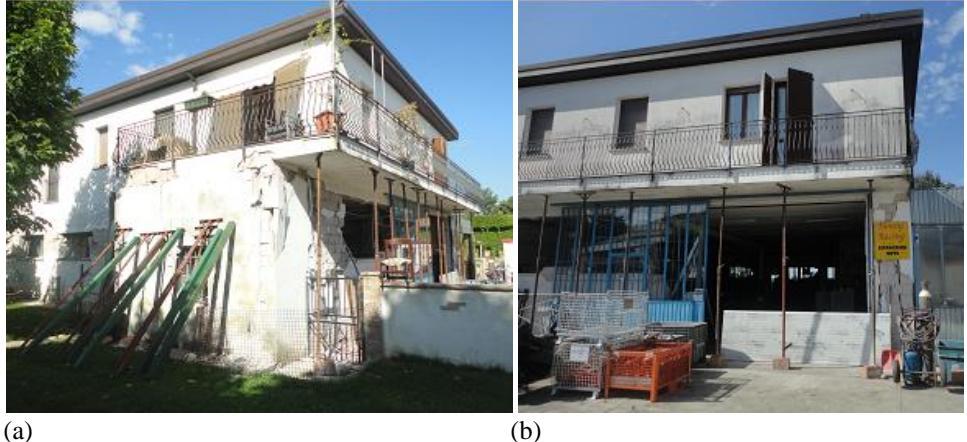
Figure 6 House in San Possidonio: (a), (b) general view of the building and of the 247 external damages caused by the Emilia's earthquake. 248

During the Emilia's earthquake, the building was subjected to a maximum PGA of 258 0.33g (see Figure 5a) that caused heavy damages to the masonry, as shown in Figures 6 259 and 8-9. The behaviour was mainly governed by the in-plane wall response, even if some 260 portions of the external walls undergone local out-of-plane collapses (see Figure 8b, over 261 the opening on the right). Diagonal shear cracks in masonry piers of the ground floor, 262 263 together with crushing phenomena can be recognized in Figures 6, 8 and 9. This widespread damage was the consequence of some deficiencies in the structural 264 conception of the building, which was not designed for seismic resistance, but only for 265 266 carrying vertical loads. The main element of vulnerability was represented by the lack of a sufficient amount of walls along the two main directions, which was respectively equal 267 to about 2% and 2.6% of the floor gross area. This insufficient "wall density" caused the 268 appearance of high stress levels on the piers at the ground storey, leading to a reduced in-269 plane deformation capacity for shear mechanisms. 270

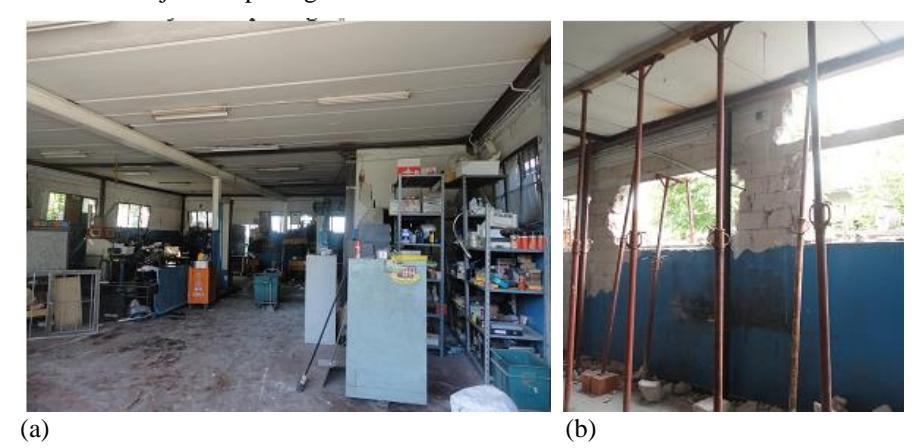
Figure 8 (a) Internal view of groundfloor and (b) detail of diagonal cracks in masonry piers between adjacent openings.

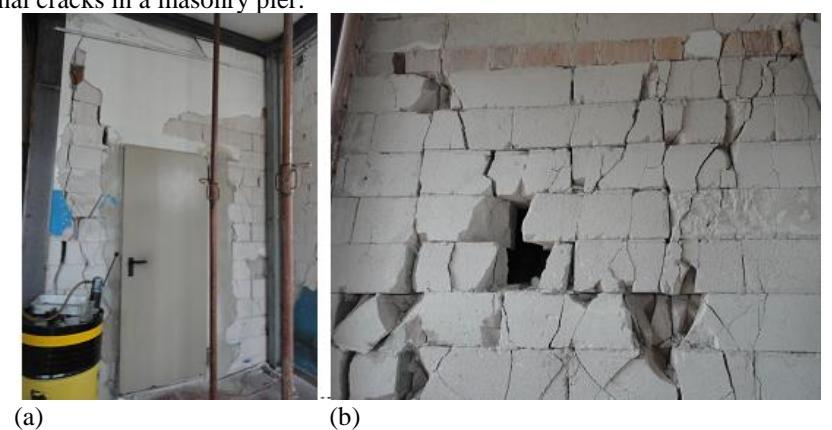
Figure 9 (a) Crack pattern at the connection zone between perpendicular walls and (b) 290

diagonal cracks in a masonry pier.

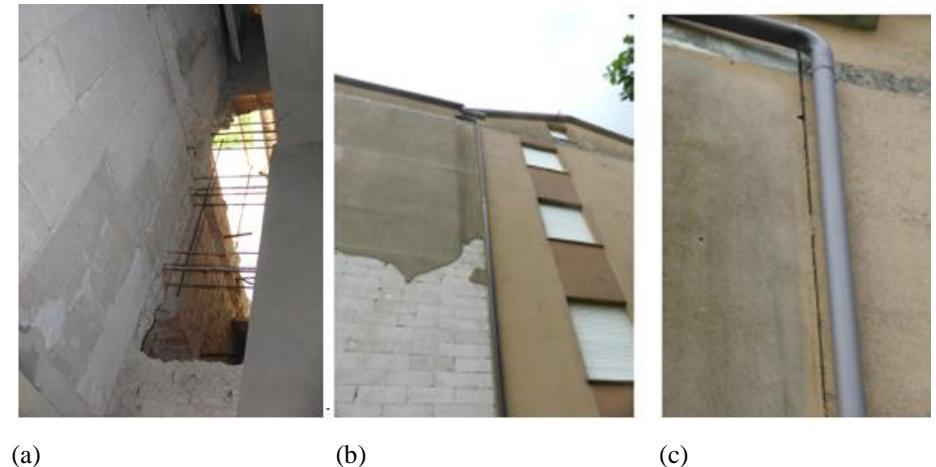
This new part was made of 250 mm thick AAC masonry with a density almost equal to 5 kN/m<sup>3</sup>, except for the ground storey, which was built again with solid bricks (as can be seen in Figure 12a). Inter-storey floors were similar to those adopted in the older part of the building, but a flat roof was chosen in this case (see Figure 10a). The connection between the two adjacent parts was not realized according to good practice rules and several localized detachment of plaster took place during the earthquake, due to the relative movements of the two parts (Figures 12b,c).

Figure 12 (a) Presence of solid clay bricks at the ground level of the newest part of the 328 building, under AAC masonry; (b), (c) general view and detail of the connection between 329 the two parts of the building realized at different times. 330

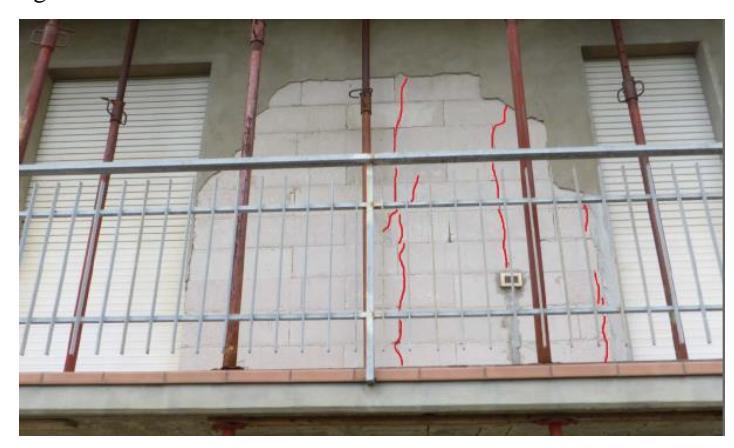
The most significant damages undergone by the building during the seismic shakes 320 were concentrated in the newest part of the building, and are depicted in Figures 13 and 321 14. The maximum attained PGA was also in this case equal to 0.33g, according to Figure 322 5a. The crack pattern was mainly constituted by sub-vertical cracks, together with 323 crushing phenomena and detachment of large portions of plaster. These damages were 324 primarily localised at the first floor (which is the lower one made of AAC), both at the 325 connection zone between two perpendicular walls and in the masonry piers between two 326 327 openings.

- 332 (a)
- Figure 13 Plaster detachment and sub-vertical cracking in AAC masonry at the first level 333 of the building. 334

337 This type of cracks is quite common in slender piers subjected to not negligible compressive stresses and has been also observed in laboratory tests, like those carried out 338 by Rosti et al. (2016). The existence of quite large vertical compressive stresses, which 339 were due to the relatively high number of storey and to the limited ratio between walls 340 and floor area, reduced indeed the displacement capacity of the masonry, so leading to a 341 premature failure. This problem was further worsened by the presence of garage 342 entrances at the ground floor, which further reduced the extension of masonry piers. To a 343 certain extent, it is also possible that the observed failure mode had been influenced by 344 the lack of mortar in vertical joints and by the fact that a common mortar for brick 345 masonry, instead of the specific mortar/glue for AAC, was used for the filling of bed 346 joints. 347

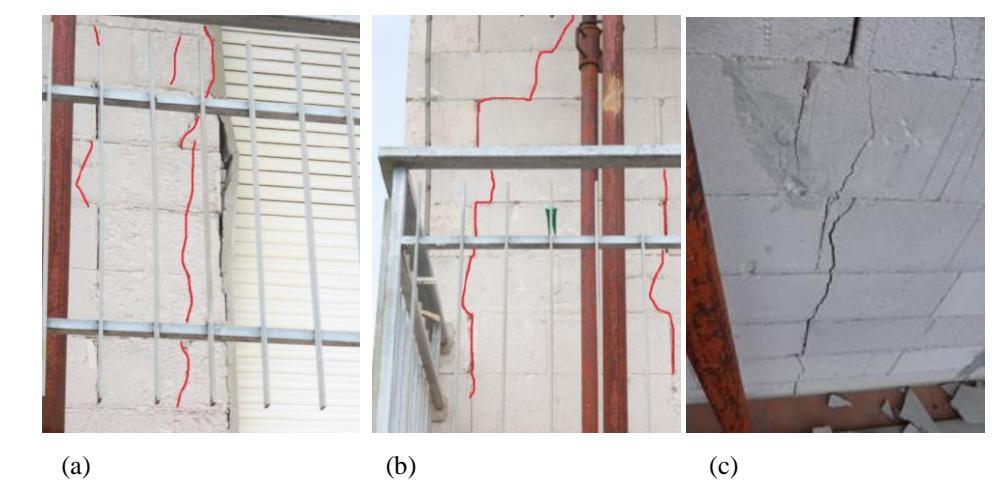
Figure 14 Details of sub-vertical cracks in the AAC masonry of the rear facade of the 349 building, behind the balconies: (a) near an opening; (b) near the connection between two 350 351 perpendicular walls; (c) in the central part of a masonry pier.

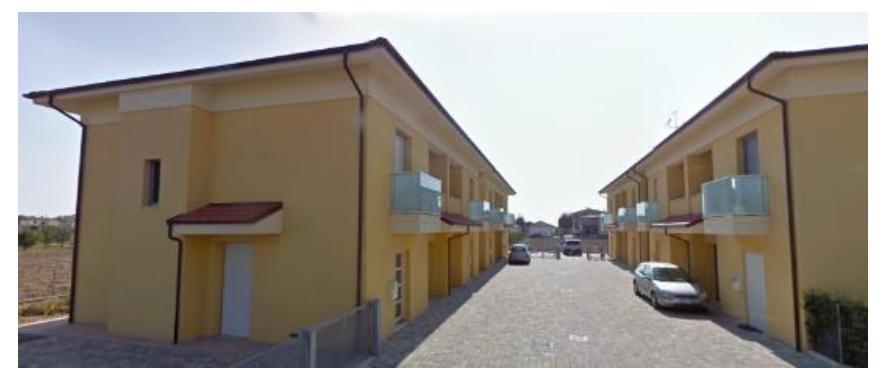
Figure 15 Residential complex made of unreinforced AAC masonry in Altedo (Bologna). 362

370 The post-earthquake inspection survey did not reveal the presence of any cracks and 371 damages nor in the peripheral nor in the internal walls. In any case, it should be observed that the building was subjected to a relatively low seismic action, since the reference peak 372 ground acceleration prescribed for that area by the actual Italian Standard Code is 0.21g. 373

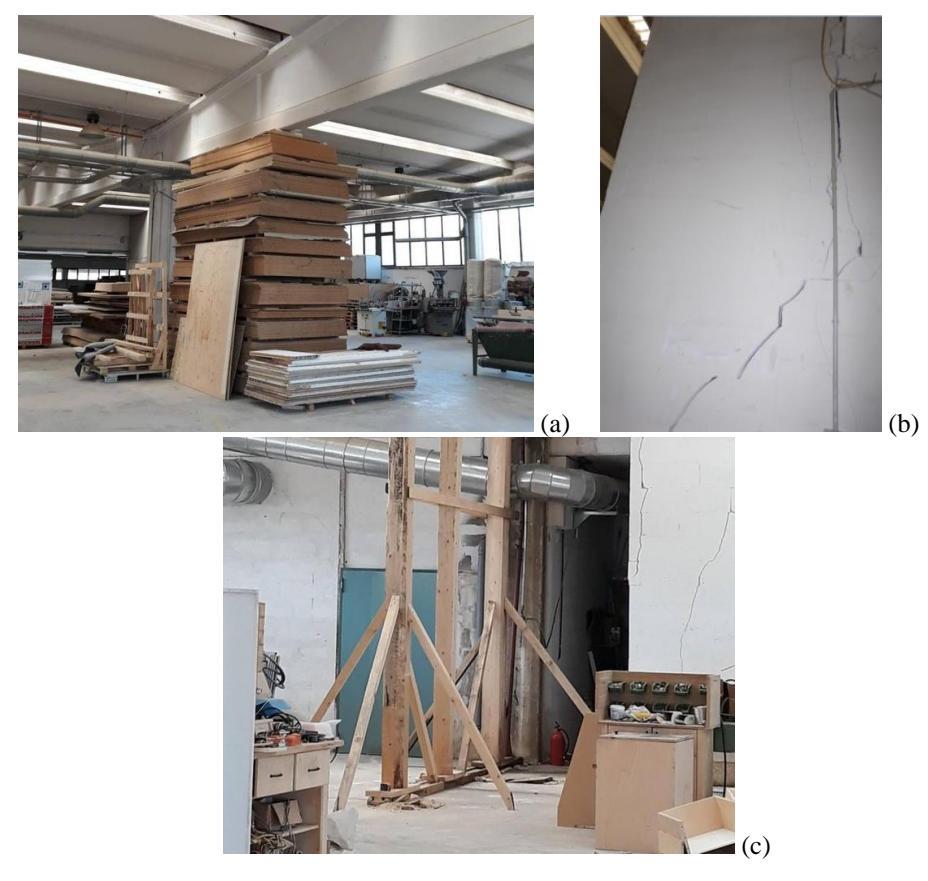
Figure 22 (a) Internal view of the furniture factory in Muccia; (b), (c) crack pattern in
 AAC masonry partitions.

450 AAC masonry partitions presented diffused shear cracks (Figures 22b,c), probably 451 because of the remarkable deformability of the RC structure and the consequent 452 interaction with non-structural walls. This type of damage was documented also in the 453 industrial precast buildings after the Emilia 2012 earthquake, regardless of masonry 454 typology (Savoia et al., 2017).

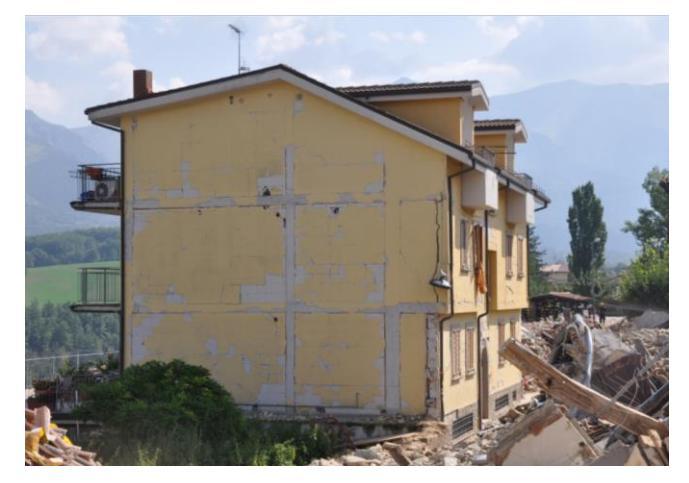
455 Another interesting case study is a reinforced concrete building in Amatrice, with AAC masonry infills. The photo reported in Figure 23, taken in September 2016, shows 456 that the building survived the first two main shocks, with AAC masonry infills detached 457 from the concrete frame but still in place. The maximum PGA after the second shock was 458 0.66g. The relatively good behaviour of the building can be explained considering that 459 Amatrice was a seismic area since 1915 and the Italian Standard Code prescribes a 460 reference PGA of 0.329g (Figure 20b). For this reason, we are dealing with an engineered 461 building with seismic detailing. Furthermore, the response spectra of the earthquake was 462 less demanding for the periods typical of deformable RC buildings (Mollaioli et al., 463 2018), as can be seen in Figure 20b. 464

Figure 23 Reinforced concrete framed building with AAC masonry infills in Amatrice
 (courtesy of Andrea Penna, adapted from Fragomeli et al., 2017).
