Hoopng as an Ancient Remedy for Conservation of Large Masonry Domes / Ottoni, Federica; Blasi, Carlo. - In: INTERNATIONAL JOURNAL OF ARCHITECTURAL HERITAGE. - ISSN 1558-3058. - 10:(2016), pp. 164-181. [10.1080/15583058.2015.1113335]

Hooping as an Ancient Remedy for Conservation of Large Masonry Domes

Federica Ottoni and Carlo Blasi

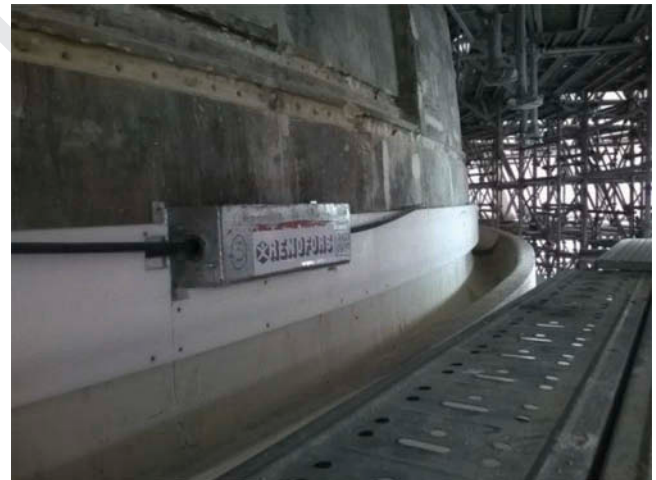
Figure 16. The new iron hoopings, realized by two pre-tensioned high resistance cables, recently added around the French Pantheon dome.

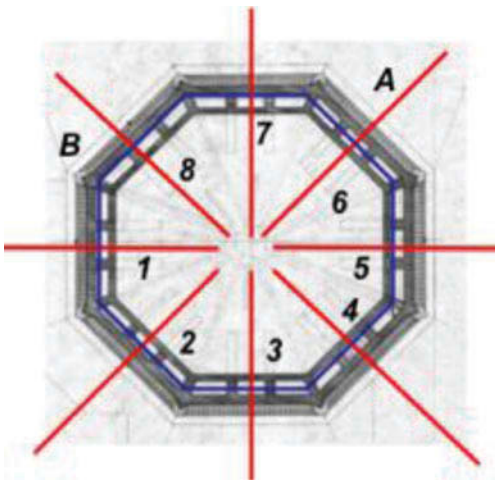
Figure 19. The crack pattern in Madonna dell'Umiltà dome: A (in red) and B (in blue).

by almost symmetrical cracks. In step with the commonly recognized classification (Tonietti, Ensoli, and Calonaci 1992), the whole crack pattern can be fully described as follows (Figure 19):

- A: Major piercing cracks (on both the domes) with vertical direction, lay at the center of the eight webs, being visible from the inside. They start from the impost level and continue upwards, cutting the tambour throughout its whole thickness, up to around 60°.
- B: Other major cracks are due to the separate movements of the two shells. Even notable detachments are visible between the intrados of angular ribs and the extrados of the inner shell, between 55° and 75°. Some passing cracks cut the median and central ribs, with vertical direction on the median ribs, testifying the relative movement between the two shells.

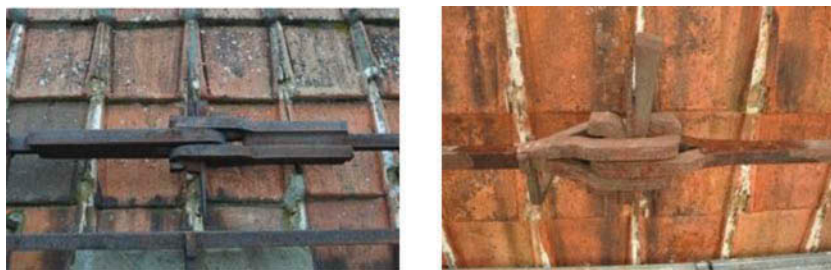
Figure 24. Two different junction systems present on the dome, belonging to the two different period: (a) 1570 and (b) 1620.

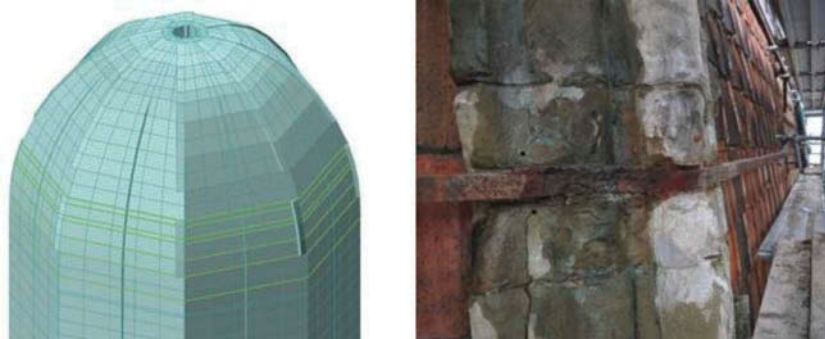
Figure 25. On the left, the linear elastic model: (a) the real nodes at the 8 vertices of the dome.
