World Multidisciplinary Civil Engineering-Architecture-Urban Planning Symposium 2016,
WMCAUS 2016

Non-smooth dynamic analysis of local seismic damage mechanisms of the San Felice Fortress in Northern Italy

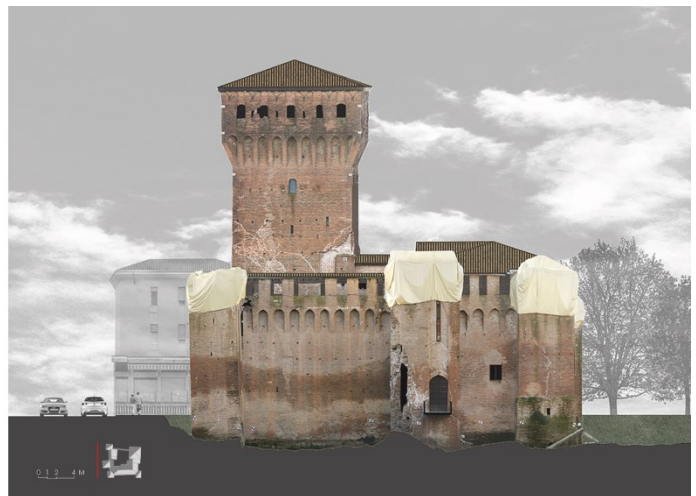
Fig. 2. Plan of the ground floor. The red rectangle identifies the zone that was modeled. Right: the fortress after the earthquake.

The analysis focused on the major collapse mechanisms identified (see Fig. 2): (a) walls curtain battlements; (b) columns of the external stairs; (c) east wall; (d) battlements of the towers; (e) building on the west side. As an example, we report here the analysis of the latter, which is the most complex.
