The construction of a street never opened to traffic. The extraordinary discovery of pavement engineering in vicolo dei Balconi of Pompeii / Autelitano, F.; Bruno, N.; Martinelli, R.; Calvanese, V.; Garilli, E.; Biancardo, S. A.; Dell'Acqua, G.; Veropalumbo, R.; Zerbi, A.; Roncella, R.; Giuliani, F.. - In: JOURNAL OF CULTURAL HERITAGE. - ISSN 1778-3674. - 54:(2022), pp. 108-117. [10.1016/j.culher.2022.01.012]

Original article

The construction of a street never opened to traffic. The extraordinary discovery of pavement engineering in vicolo dei Balconi of Pompeii

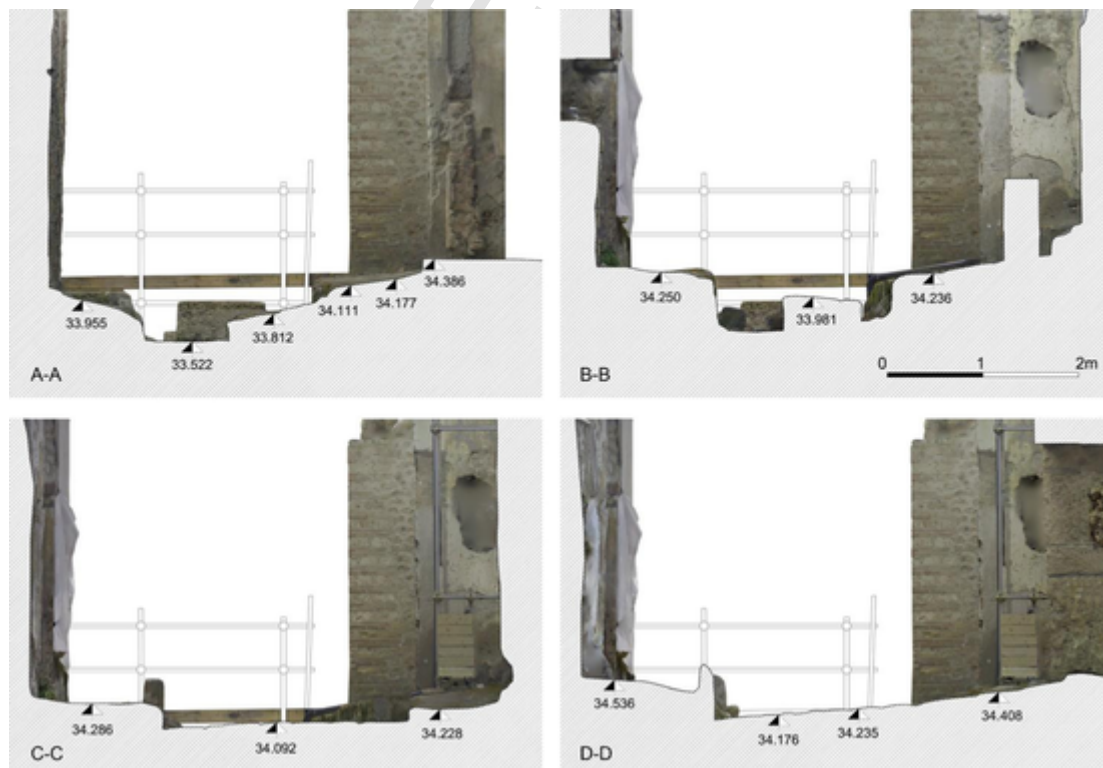
Fig. 5. Cross sections of vicolo dei Balconi (reported in Fig. 2).

The street section of vicolo dei Balconi provides the arrangements of curbs using large stone blocks, resulting in a sidewalk level rather high compared to the original laying surface or to the specifically prepared one. The worksite area between the new paved completed section and the southern junction with via di Nola has currently a preparatory subgrade consisting of an apparently pre-existing altered *glarea* [23], in which three prismatic stone blocks are placed on a provisional bed of coarse stones. These blocks seem to represent targets in the paving progress, perhaps useful for the alignment of the future finished surface as well as for the easier temporary alley crossing for pedestrians and workers (masons) (Fig. 5). The longitudinal profile highlights an essential regularity between the sidewalk level (existing curb) and the paved surface (about 230 mm) both along the eastern and western sides (Fig. 6).
