FROM “MODELS” TO “REALITY”, AND RETURN. SOME REFLECTIONS ON THE INTERACTION BETWEEN SURVEY AND INTERPRETATIVE METHODS FOR BUILT HERITAGE CONSERVATION

F. Ottoni ^{aa*}, F. Freddi ^a, A. Zerbi ^a

^a Dept. of Engineering and Architecture, University of Parma, Parma, Italy - (federica.ottoni, francesco.freddi, andrea.zerbi)@unipr.it

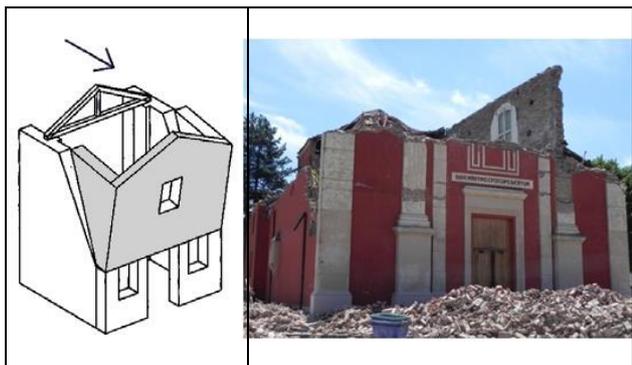
Figure 1. The evidence of “local mechanism” during an earthquake: on the left, the mechanism of façade turning, and on the right the evidence of this mechanism after the strong Emilia Romagna earthquake (May 2012).

It's well known from literature (Giuffrè, 1982; Giuffrè and Carocci, 1993; Lagomarsino, 2006), and it has been formalized by the recent Italian law in the field of cultural heritage structural conservation (Direttive, 2011) that ancient masonry structures do not show a “global behaviour” but – for the presence of cracks and physiological partialization – they can be rather divided in macro-elements, each showing quite independent behaviour. This phenomenon is fully evident in case of earthquake (Fig.1).

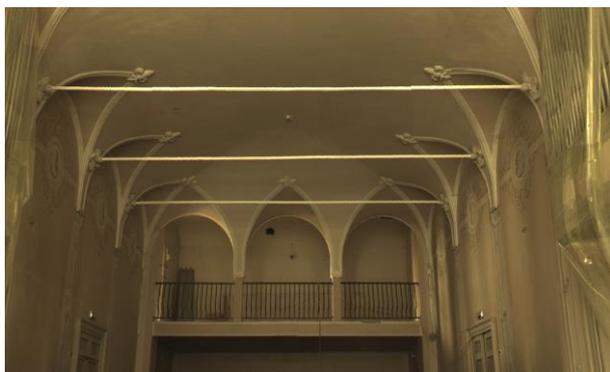
Figure 2. The nailed and lowered profile pavilion vault which covers the Sala Verdi of Conservatorium, in Parma (Italy)

The first case here presented is the analysis of a XIX century pavilion vault which covers the Sala Verdi of the Conservatorium in Parma (Italy). The geometry of this great vaulted room is complicated by its organization into regular nails – three on the short sides and eight along the long ones – which are abutted on the central lowered profile barrel vault (Fig.2).

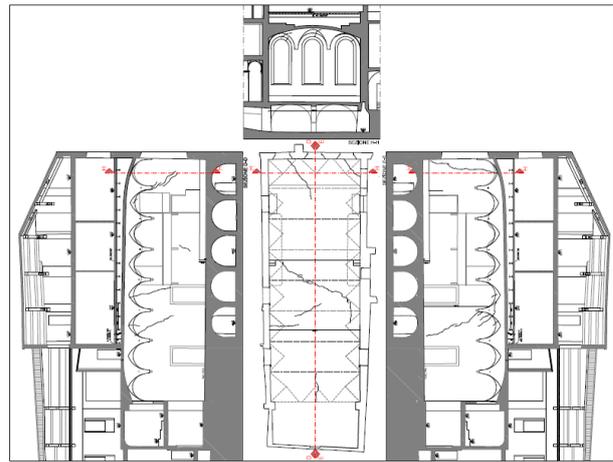
Figure 3. Scheme of the crack pattern of the great vaulted hall.

A map of these cracks has unravelled a shape which seems to be only partially consistent with the collapse mechanism typical of vaulted structures, though it has shown the well known lowering of the top of the vault mainly due to its own weight (Fig.3).

Somewhat, the series of inclined cracks along the two longitudinal walls seemed to be imputed to a differential settlement of the northern part of the hall: in particular, two main inclined cracks prosecute the main one which cuts the vault transversally, and other major cracks are present in the northern nails and on the longitudinal walls, just near the northern corners of the room, letting hypothesize a mechanism of collapse actually compatible with a differential settlement of the north wall.

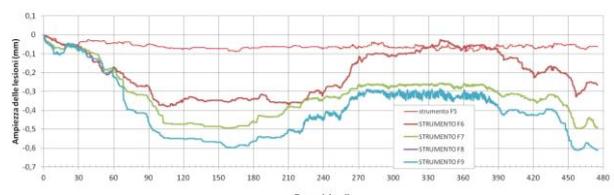
Figure 4. Trend of the four instruments installed in Sala Verdi: on x axis time (days) is plotted and on y the crack width (mm).

Indeed, a precision monitoring system (Fig.4) has been installed on the main cracks of the vault and the underlying structures, in order to achieve more precise information on their amplitude and global trend, also considering seasonal variations. In particular, 4 digital deformometers (F1-F4), temperature integrated, wireless, were installed since March 2012, each registering crack width and temperature data every six hours. Moreover, in November 2016 the instrument inserted on the vault was repositioned on the west-north wall, in order to better understand the possible differential settlement of the northern part.

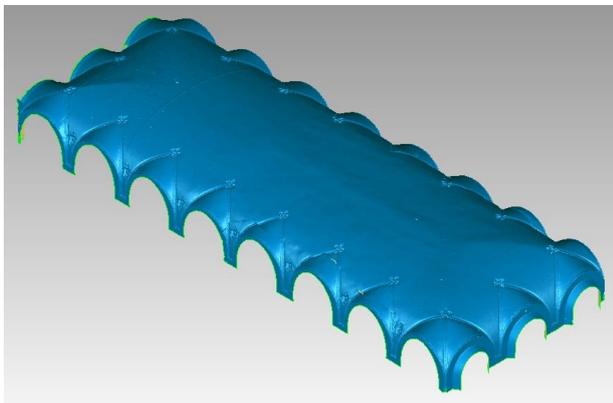
Figure 5. The 3D geometrical model

Recording the full 3D geometry of the vaults was straightforward by scanning from different stations (Fig.5).

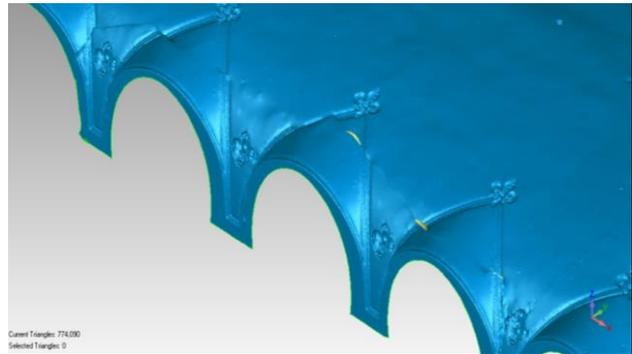
Figure 6. The voids (or “shadows”) in the laser scanner model

Despite fully satisfactory for surveying the vault surfaces and the decorative apparatus, laser-scanning operation has to be carefully planned, particularly when, as in this case, some areas in the scene cannot be properly registered. In this case, the some obstacles, as the two organs on the north side of the longitudinal walls, and the complex geometry of the vault, represented by the nails, have generated some voids in the resulting cloud model, generally referred to as “shadows” (Guidi et al., 2014). In the final geometrical model of the hall, a number of “areas of shadow” were found, approximately on the intersection of the lateral nails with the pavilion vault, and, obviously, in the northern part of the longitudinal wall, beyond the organs.

In particular (Fig.6), these voids are detectable in the central six nails on the longitudinal sides of the hall (three for each side), and in the portions of vaults in between them.

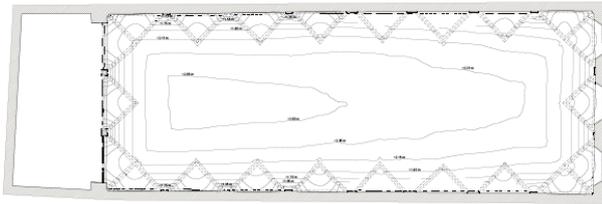
Figure 7. Level curves of the vault: north side on the right

Given the primary scope of this research, the information on the vault curvature was achieved by tracing along intrados, lines using the point of cloud model. We have to notice that the standard deviations, inevitable in this procedure, can be considered acceptable, considering the large span of the examined vault. As the goal of the study was to investigate the relation between vault deformation and possible collapse mechanism, in order to understand the primary cause of the damage, a further file with only some cut plane have been plotted, in order to better understand the deformation on the vault referred to the hypothesized mechanism of differential settlement towards north direction (Fig.7).

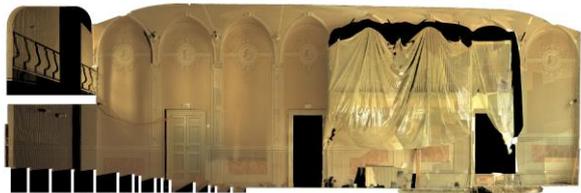
Figure 8. Longitudinal section of the vault, achieved by the laser scanner survey

We will see that this simple graphical elaboration, together with the classic longitudinal section of the hall, more than accurate and snappy refined 3D model, can give, almost in this case, an interesting interpretative key of the main global movement of the vault, if properly coupled with the result of monitoring and numerical model analysis of the monument.

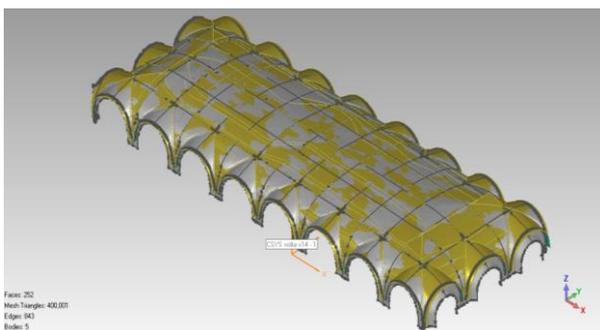
Figure 9. Reconstruction of the surface, discretized by triangles

Then, the surfaces of the model were smoothed and cleaned and the geometry has been completed under the two organs, on the northern side of the longitudinal walls. After these operations, a corrected surface has been reconstructed and discretized by triangles (Fig.9).

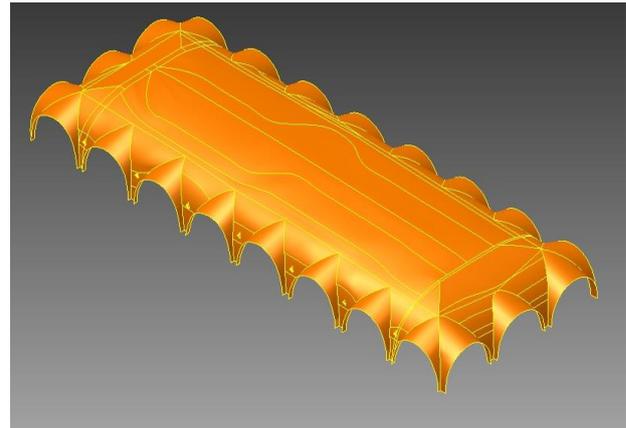
Figure 10. The FEM model of the vault

Therefore, the vault has been modelled through a discretization by shell-type elements (Fig.10), considering a vault thickness of 15 cm. Given the strong irregularity of the surveyed

Here the values applied to the FEM model:

Specific weight: 1750 kg/m³

E (Young modulus): 5500 MPa

Poisson coefficient: 0.15.

In order to correctly simulate the structural behaviour of the vault, the perimeter walls have been inserted at the impost through elastically yielding constraints which actually simulate the stiffness of these elements. Moreover, minor stiffness conditions have been inserted along the two short sides (south and north wall) in order to reliably take into account the different boundary conditions: three slender small columns on the south side and a slender external wall with three wide openings on the north side. Moreover, the existing tie-rods (seven, installed between two consecutive nails along the transversal section of the barrel vault) have been inserted in the model, as achieved by the survey.

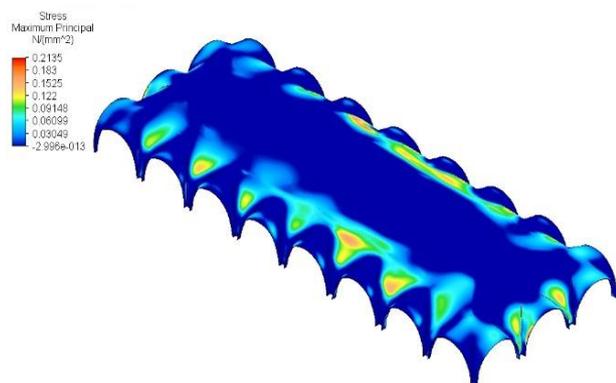
Figure 11. Total σ_{11} – principal stress values

After processing, the model evidenced for this structure the classical behaviour of masonry vault, with major deformations, as predictable, on the top of vault and generally less than 1.3 mm (limited after all, considering the vault span), unless some irregularities due to the considerable lowering on the northern part of the vault itself, as strongly evidenced by the geometrical survey (Webb et al., 2016.). Also the maximum stress values are acceptable in relation to the mean strength capacity of the material, both at the intrados and at the extrados of the vault (mean values are around 0.15-0.18 MPa) and the compressive stresses are always under 1 MPa, thus far away from the material strength capacity. Some peaks are imputable more to unrealistic deviations on the geometrical model (inevitable with this level of information accuracy) rather than to real state of stress (Fig.11).

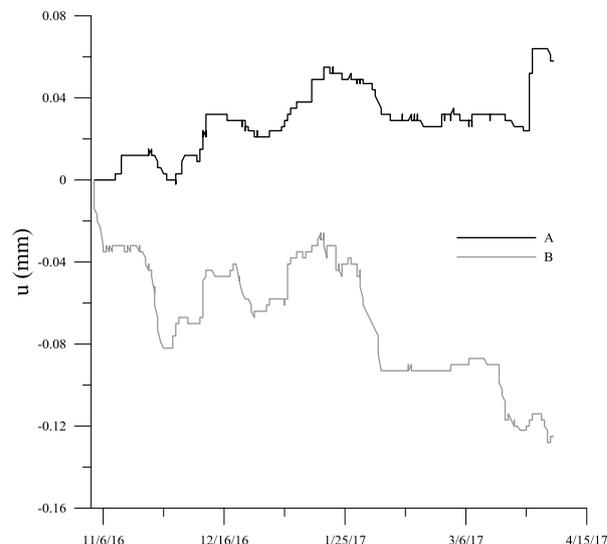
Figure 12. Crack width (mm) of the two instruments installed on the two longitudinal walls (A west wall; B: east one), near the northern part of the hall.

Indeed, by examining the data recorded by the two instruments installed on the inclined wide cracks which cut the longitudinal walls, near the northern part of the hall, it's possible to better understand the real consistency of the hypothesized (and partially surveyed) differential settlement of the northern wall.

In figure 12 is plotted the relative behaviour of the two sides of the macro-element constituted by the northern portion of the Sala Verdi: while a differential settlement of this portion is confirmed, the plotted data show a rotation towards northwest direction of the northern wall. This analysis adds fundamental information on the real mechanism which actually involves the examined structure, leading to set up reliable strategy of structural restoration.

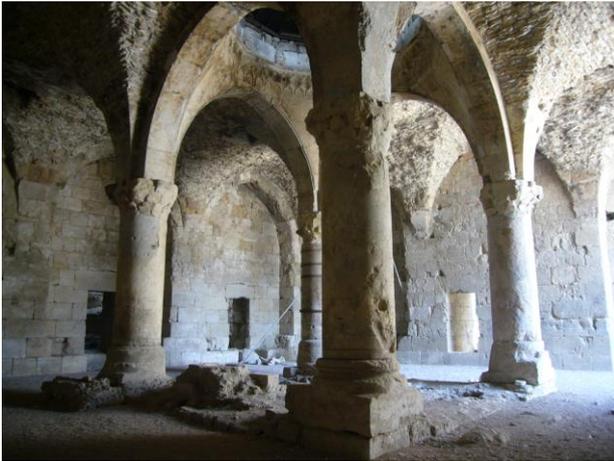
Figure 13. The great vaulted Ayyubid Hall

hall (the Ayyubid Hall, Fig.13) and two towers at the north-eastern (Tower 8) and north-western corners (Tower 12) of the Citadel. these buildings unravelled complex structures, which has been significantly modified during the centuries (Otoni et al., 2008).

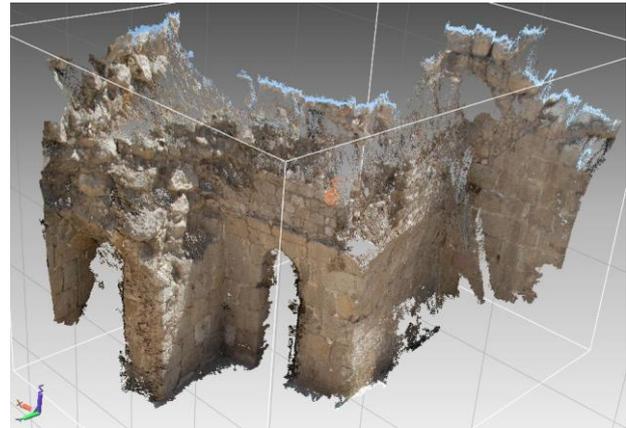
Figure 14. The point clouds obtained by the algorithm, at the upper level of Tower 12.

By applying this algorithm, every object planar feature has been correctly mapped in its corresponding position on the representation plane, regardless of its orientation: at the same time, in the same mapping frame elements not strictly coplanar or parallel are represented adequately. Moreover, dense 3D point restitution, using experimental automated algorithms (Structure from Motion based approach), has been performed in order to extract interesting sections and point cloud (Fig.14).

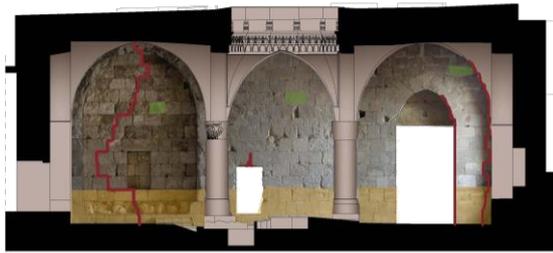
Figure 15. The crack pattern surveyed on the north internal wall of the Ayyubidd Hall

Concerning the static aspects, the Ayyubid Hall demonstrated a general good static state, which could be, nevertheless, strongly compromised after the scheduled demolition of the more recent building lying on its west side. This fact, coupled with the surveyed crack pattern of the hall (Fig.15), led us to reliably considering the possible rotation of one of the external walls, free under the vaults thrust and the seismic action, as the most probable collapse mechanism of the structure (Fig.16).

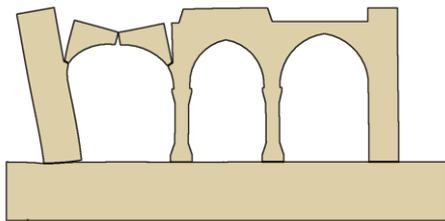
Figure 16. The hypothesized mechanism of collapse for the Ayyubidd Hall, with the 5 hinges typical of vaulted structures.

In this calculation we have considered the scheduled reduction of the filling on the extrados of the vaults for 90 cm.

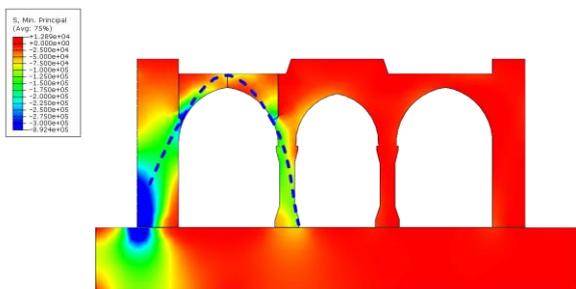
Figure 17. The results of the simplified 2D FEM model: principal stresses are plotted, which correspond to the hypothesized hinges.

The 2D simplified model realized with the FEM code actually revealed the same mechanism, stressing the creation of natural hinges between the different elements, following the well known typical collapse mechanism of arches, which matched with the followed analytical path (Fig.17).

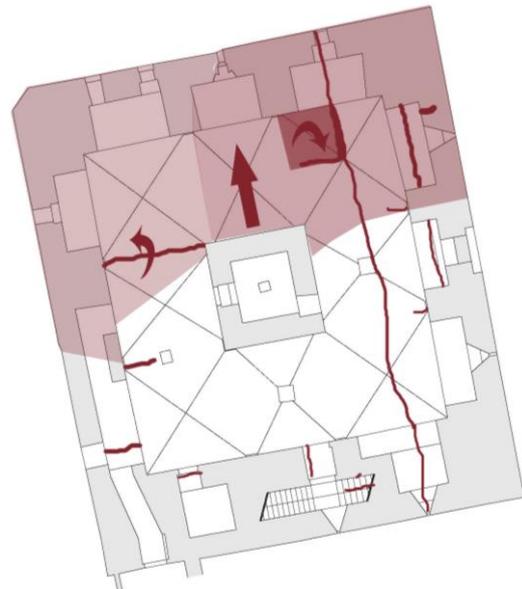
Figure 18. Scheme in plan of the main cracks and surveyed movements of the Tower 8: a rotation of the northern wall.

The same simplified methodology has been applied to the Tower 8 in which the cracks, together with the results of the previous accurate geometrical survey (the progressive movement of the central pillar to the north and the identified drop toward North of the floors) allowed to identify the principal movement of the structure (Fig.18).

Also in this case, starting from the geometrical survey and the mapping of the crack patterns, supported by an in depth historical research, it has been possible to identify two main mechanisms which would synthesize the structural damage in this building: a capsizing movement of the north walls of the tower, mainly due to seismic actions, coupled with a general subsidence phenomenon of the soil (for the presence of the near Barada river, which flows on the north side of the tower).

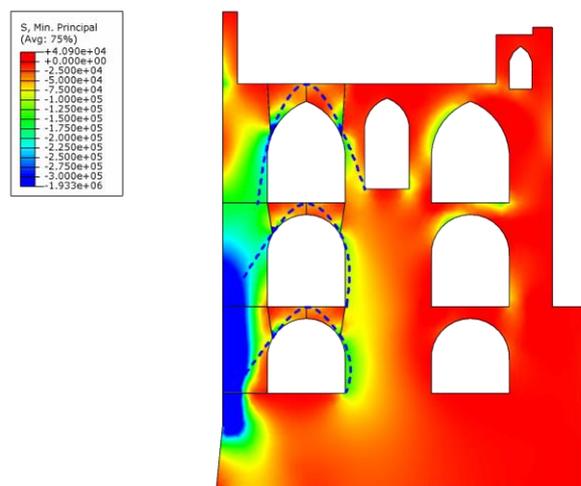
Figure 19. The results of the simplified 2D model

Indeed, the combined historical and geotechnical analyses carried out evidenced a vertical partitioning of the soil, due to the dead weight of the tower, increased in times by the progressive drop of the water table. The mechanical characteristics of the soil have been translated into the F.E.M. model in order to verify the effects on the structure of the hypothesized phenomenon. Moreover, as in the previous case of Ayyubidd Hall, a very simplified 2D model of the complex geometry of the building has been reconstructed in order to simulate the probable rotation of the external walls, subject to the double action of thrusts of the great vaults and conceivable future earthquakes. The simplified mechanism has been solved by using the equilibrium approach for the three superposed structure, working out step by step the reaction forces applied in the identified hinges on the horizontal planes and the model realized with the FEM code has revealed the same mechanism, stressing the creation of hinges at the same positions (Fig.19).
