Damage assessment of autoclaved aerated concrete buildings: some Italian case studies

Damage assessment of autoclaved aerated concrete buildings: some Italian case studies / Ferretti, Daniele; Michelini, Elena; Pongiluppi, Nicola; Cerioni, Roberto. - In: INTERNATIONAL JOURNAL OF MASONRY RESEARCH AND INNOVATION. - ISSN 2056-9459. - 5:1(2020), pp. 279-301. [10.1504/IJMRI.2020.10024371]

1 **Damage assessment of autoclaved aerated concrete**
2 **buildings: some Italian case studies**

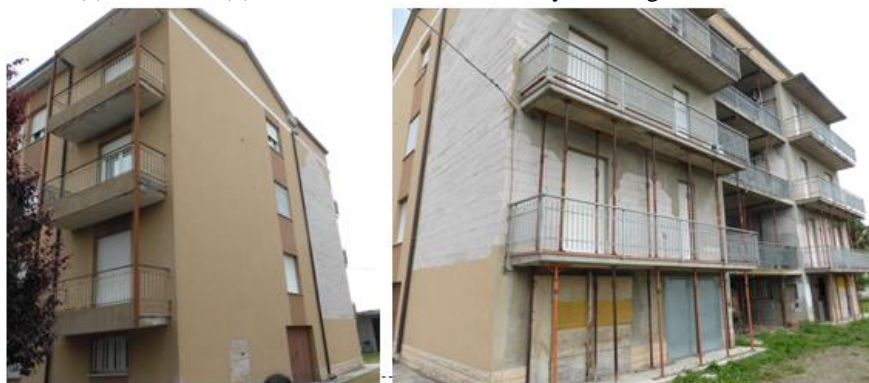
296 Another example of AAC masonry structure not designed according to seismic rules and
297 heavily damaged during the Emilia's earthquake is the 5 storey building depicted in
298 Figures 10-11. The building, located in San Possidonio (Modena, see Figure 4), was
299 formed by two parts, realized in different times. The first and ancient part (Figure 10a)
300 was built in the '60s by using solid clay bricks, transversally disposed within the wall
301 thickness and forming a single-leaf masonry (header bonding). Inter-storey floors were
302 realized with parallel RC joists separated by hollow clay blocks, while the pitched roof
303 was made with precast "Varese" RC joists and interposed non-refractory clay flooring
304 blocks. The second and more recent part, circled in red in the plans of Figure 11 and
305 corresponding to the rear of the building (see also Figure 10b), was added during the '70s.

307 **Figure 10** (a) Front and (b) rear view of the multi-storey building in San Possidonio.

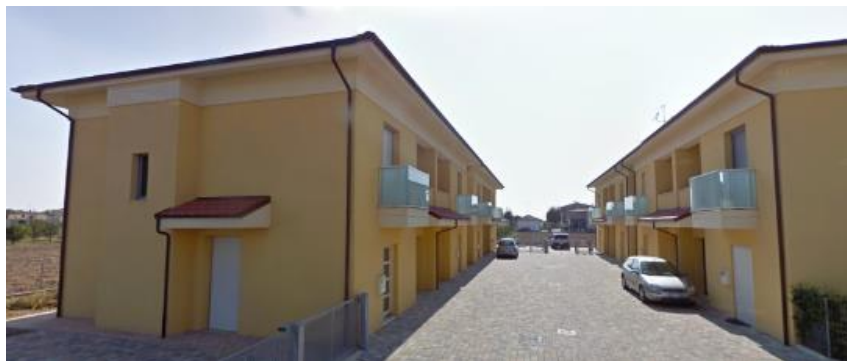
358 Figure 15 shows a residential complex made of a couple of two-storey terraced houses
359 in Altedo (in the municipality Malalbergo, near Bologna, see Figures 4 and 5b), which
360 was subjected to a maximum PGA of 0.06g during the Emilia’s earthquake.

362 **Figure 15** Residential complex made of unreinforced AAC masonry in Altedo (Bologna).

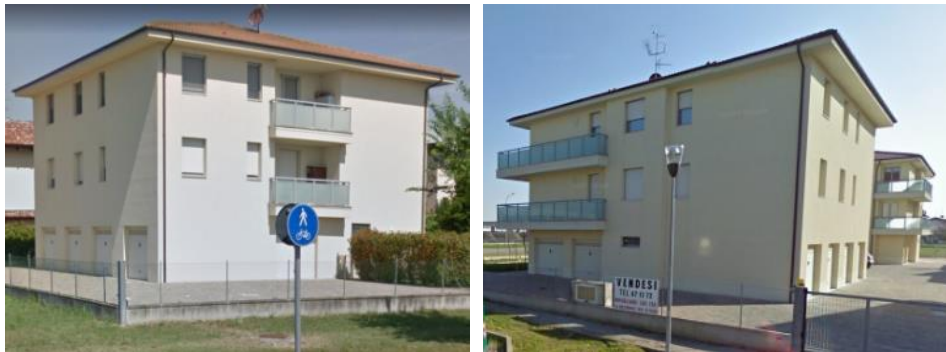
377
378 **Figure 17** Residential complex made of unreinforced AAC masonry in San Pietro in
379 Casale (Bologna).

380
381
382 The second case study is represented by a residential complex made of a couple of
383 three-storey buildings located in San Pietro in Casale (near Bologna), which undergone a
384 maximum PGA of 0.09g (Figure 5c). The buildings, depicted in Figure 17, were designed
385 according to seismic prescriptions, and were realized with 360 mm thick AAC seismic
386 blocks. The reference peak ground acceleration prescribed by the actual Italian Standard
387 Code for that area is 0.208g. No damages were detected during the post-earthquake
388 inspection survey, thanks to the substantially regular shape of the buildings, the use of
389 good quality materials and an adequate care in detailing.

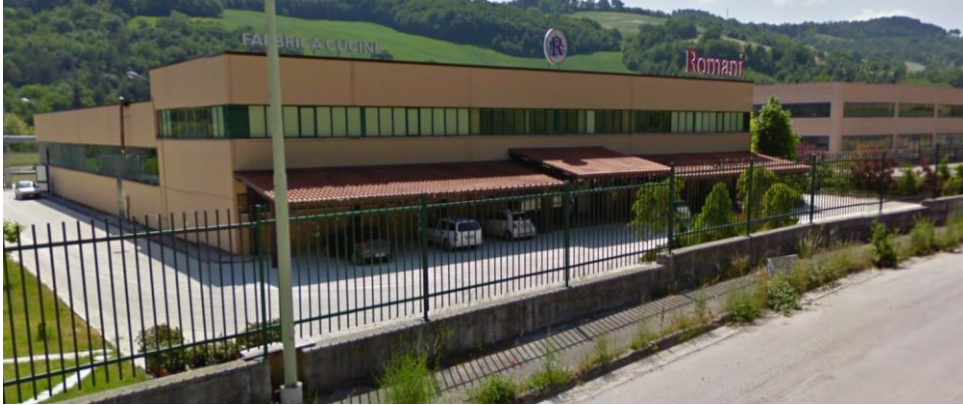
An interesting example where AAC was used for fire-resistant partitions is the furniture factory in Muccia (Macerata), shown in Figure 21. The internal view (Figure 22a) reveals a typical Italian precast concrete building, with prestressed concrete beams, precast thin-walled concrete roof elements (Belletti et al., 2016) and external panels.

437 **Figure 21** External view of the furniture factory in Muccia (Macerata).

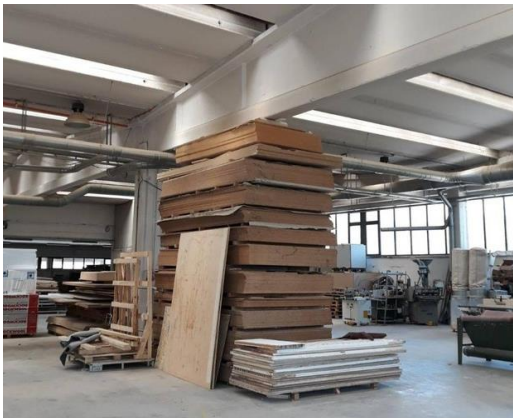
440 **Figure 22** (a) Internal view of the furniture factory in Muccia; (b), (c) crack pattern in
441 AAC masonry partitions.

450 AAC masonry partitions presented diffused shear cracks (Figures 22b,c), probably
451 because of the remarkable deformability of the RC structure and the consequent
452 interaction with non-structural walls. This type of damage was documented also in the
453 industrial precast buildings after the Emilia 2012 earthquake, regardless of masonry
454 typology (Savoia et al., 2017).

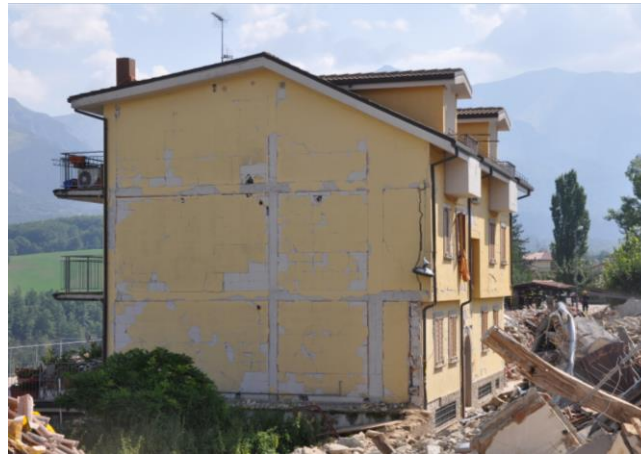
455 Another interesting case study is a reinforced concrete building in Amatrice, with
456 AAC masonry infills. The photo reported in Figure 23, taken in September 2016, shows
457 that the building survived the first two main shocks, with AAC masonry infills detached
458 from the concrete frame but still in place. The maximum PGA after the second shock was
459 0.66g. The relatively good behaviour of the building can be explained considering that
460 Amatrice was a seismic area since 1915 and the Italian Standard Code prescribes a
461 reference PGA of 0.329g (Figure 20b). For this reason, we are dealing with an engineered
462 building with seismic detailing. Furthermore, the response spectra of the earthquake was
463 less demanding for the periods typical of deformable RC buildings (Mollaioli et al.,
464 2018), as can be seen in Figure 20b.

468 **Figure 23** Reinforced concrete framed building with AAC masonry infills in Amatrice
469 (courtesy of Andrea Penna, adapted from Fragomeli et al., 2017).
