Damage assessment of autoclaved aerated concrete buildings: some Italian case studies

Damage assessment of autoclaved aerated concrete buildings: some Italian case studies / Ferretti, Daniele; Michelini, Elena; Pongiluppi, Nicola; Cerioni, Roberto. - In: INTERNATIONAL JOURNAL OF MASONRY RESEARCH AND INNOVATION. - ISSN 2056-9459. - 5:1(2020), pp. 279-301. [10.1504/IJMRI.2020.10024371]

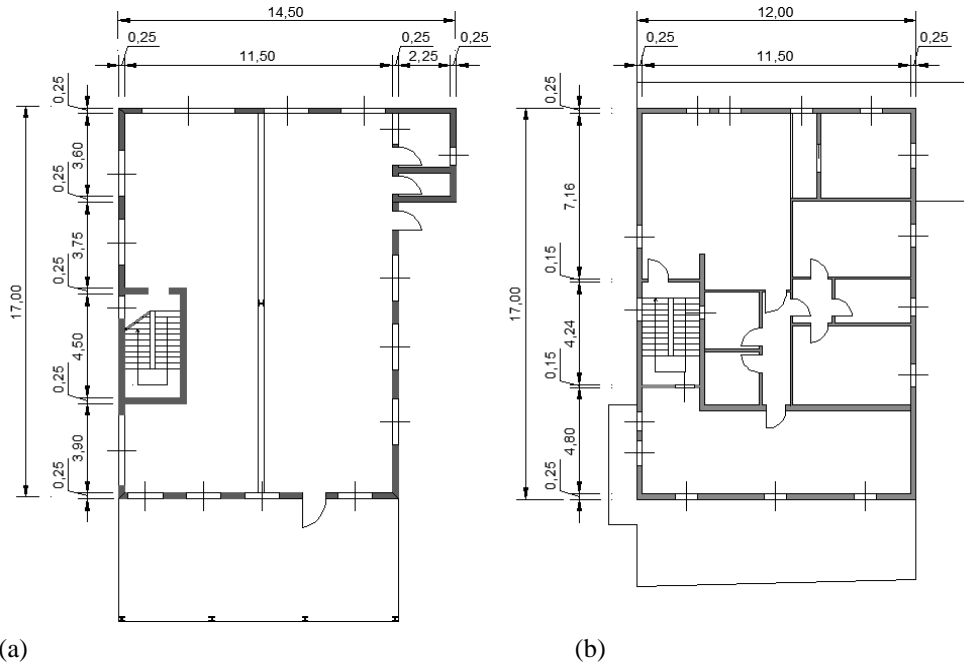
271 **Figure 7** Plans of the two floors of the building: (a) ground floor; (b) first floor.

This problem was further increased by the large distance between the bearing walls sustaining the horizontal forces (respectively equal to 12 and 17 m in the main directions, Figure 7), the relatively small thickness of the walls (250 mm), and the presence of large openings, with the consequent formation of squat masonry piers (i.e. Figure 8). Finally, Figure 9a shows the crack pattern registered at the connection zone between two perpendicular walls, near the stairs' door. From Figure 9b, it can be also seen that remarkable masonry disruption took place in AAC walls. This fact explains the rising

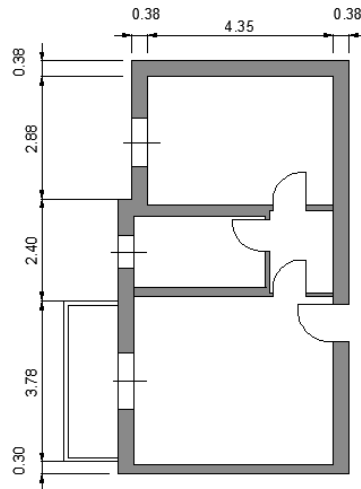
390 **Figure 18** Plan of one apartment at the third level of the residential complex in San Pietro
391 in Casale (Bologna).

393 The plan of one apartment placed at the third level of the residential building, shown in
394 Figure 18, confirms also in this case the presence of an adequate amount of bearing
395 masonry in the two main directions and the relatively small spacing between the bearing
396 walls (lower than 7 m).

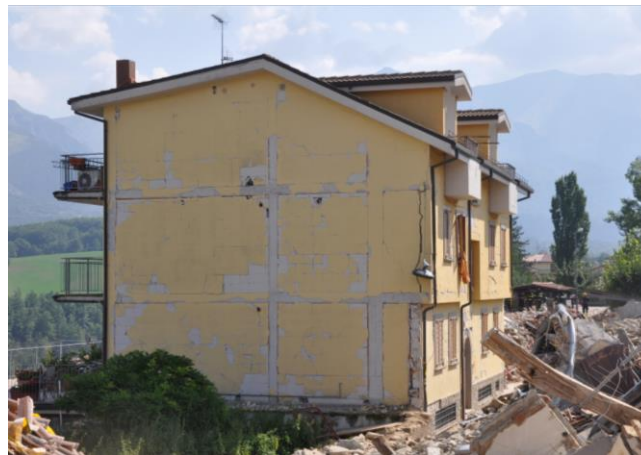
468 **Figure 23** Reinforced concrete framed building with AAC masonry infills in Amatrice
469 (courtesy of Andrea Penna, adapted from Fragomeli et al., 2017).

455 Another interesting case study is a reinforced concrete building in Amatrice, with
456 AAC masonry infills. The photo reported in Figure 23, taken in September 2016, shows
457 that the building survived the first two main shocks, with AAC masonry infills detached
458 from the concrete frame but still in place. The maximum PGA after the second shock was
459 0.66g. The relatively good behaviour of the building can be explained considering that
460 Amatrice was a seismic area since 1915 and the Italian Standard Code prescribes a
461 reference PGA of 0.329g (Figure 20b). For this reason, we are dealing with an engineered
462 building with seismic detailing. Furthermore, the response spectra of the earthquake was
463 less demanding for the periods typical of deformable RC buildings (Mollaioli et al.,
464 2018), as can be seen in Figure 20b.
