Damage assessment of autoclaved aerated concrete buildings: some Italian case studies

Damage assessment of autoclaved aerated concrete buildings: some Italian case studies / Ferretti, Daniele; Michelini, Elena; Pongiluppi, Nicola; Cerioni, Roberto. - In: INTERNATIONAL JOURNAL OF MASONRY RESEARCH AND INNOVATION. - ISSN 2056-9459. - 5:1(2020), pp. 279-301. [10.1504/IJMRI.2020.10024371]

Abstract: The present work deals with the damage assessment of some Italian 14 case studies of structures/walls realized in autoclaved aerated concrete (AAC) 15 16 blocks. Initially, examples of static damage of walls caused by excessive deformability of the slabs, differential loads on walls, and foundation 17 18 settlements, are shown. Then, the seismic behaviour of AAC masonry buildings 19 is analysed. In particular, the behaviour of two pre-seismic code buildings 20 damaged by the Emilia 2012 earthquake is described and compared with 21 modern engineered buildings. Then, the behaviour of non-structural walls damaged by the Central Italy 2016 earthquake is reported. Very few case 22 23 studies focusing on the damage assessment of AAC masonry buildings during real seismic events can be found in the

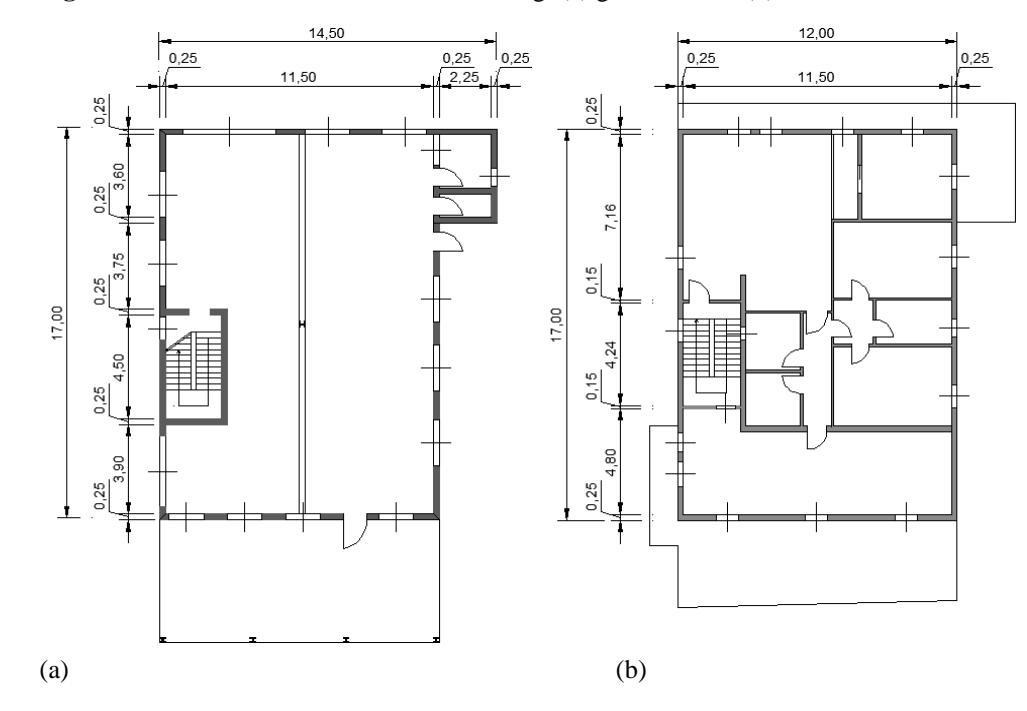
#### Figure 7 Plans of the two floors of the building: (a) ground floor; (b) first floor.

This problem was further increased by the large distance between the bearing walls sustaining the horizontal forces (respectively equal to 12 and 17 m in the main directions, Figure 7), the relatively small thickness of the walls (250 mm), and the presence of large openings, with the consequent formation of squat masonry piers (i.e. Figure 8). Finally, Figure 9a shows the crack pattern registered at the connection zone between two perpendicular walls, near the stairs' door. From Figure 9b, it can be also seen that remarkable masonry disruption took place in AAC walls. This fact explains the rising

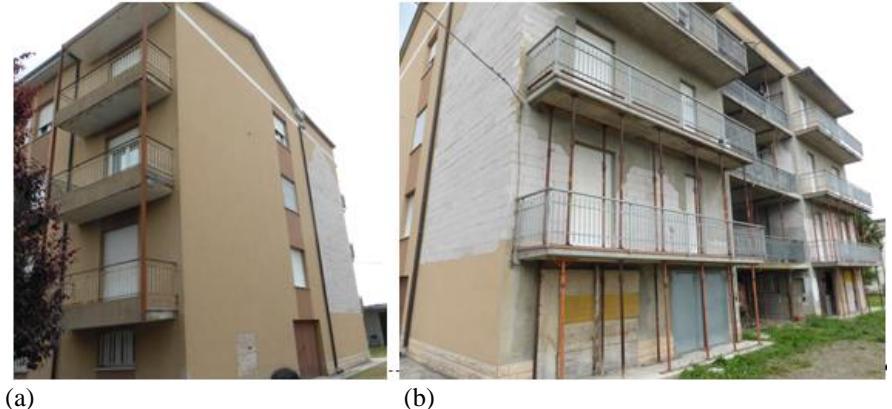
Another example of AAC masonry structure not designed according to seismic rules and 296 heavily damaged during the Emilia's earthquake is the 5 storey building depicted in 297 298 Figures 10-11. The building, located in San Possidonio (Modena, see Figure 4), was formed by two parts, realized in different times. The first and ancient part (Figure 10a) 299 was built in the '60s by using solid clay bricks, transversally disposed within the wall 300 thickness and forming a single-leaf masonry (header bonding). Inter-storey floors were 301 realized with parallel RC joists separated by hollow clay blocks, while the pitched roof 302 was made with precast "Varese" RC joists and interposed non-refractory clay flooring 303 304 blocks. The second and more recent part, circled in red in the plans of Figure 11 and corresponding to the rear of the building (see also Figure 10b), was added during the '70s. 305

Figure 10 (a) Front and (b) rear view of the multi-storey building in San Possidonio. 307

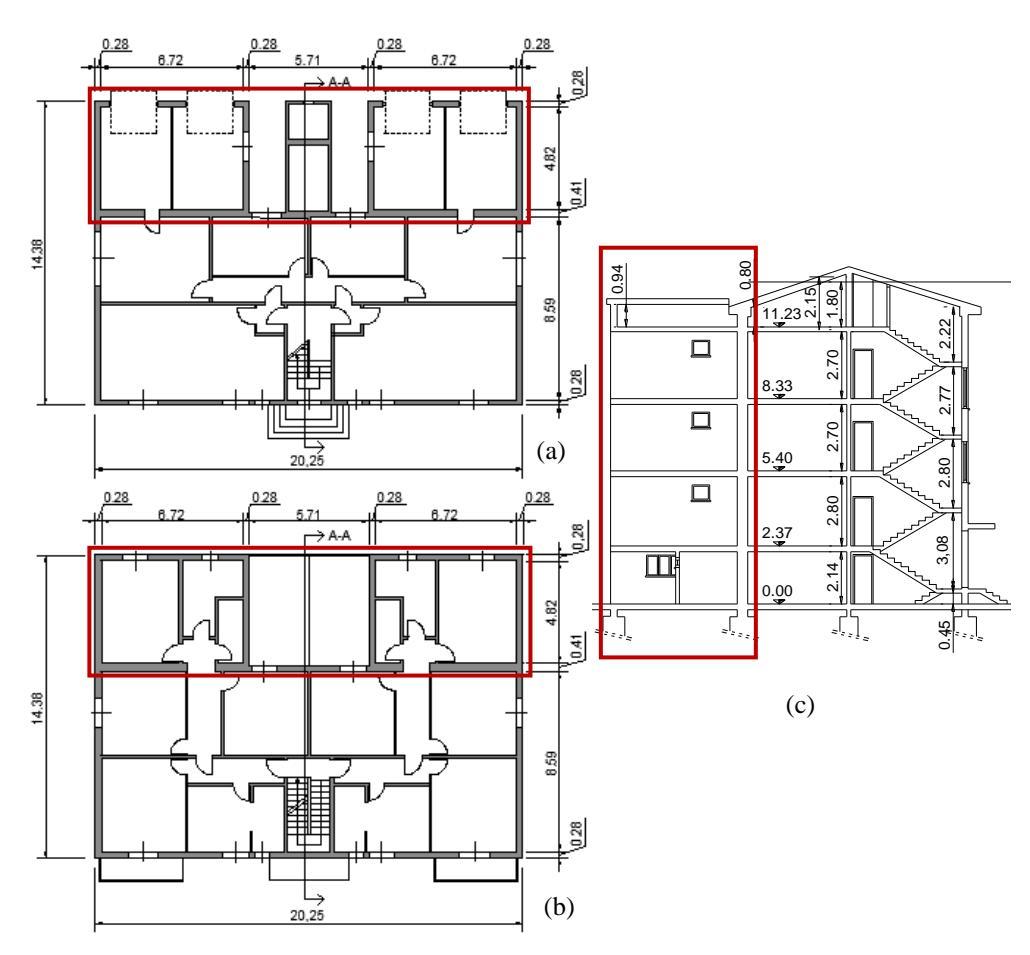
Figure 11 Plans of the building: (a) ground storey and (b) typical intermediate storey; (c)
section A-A.

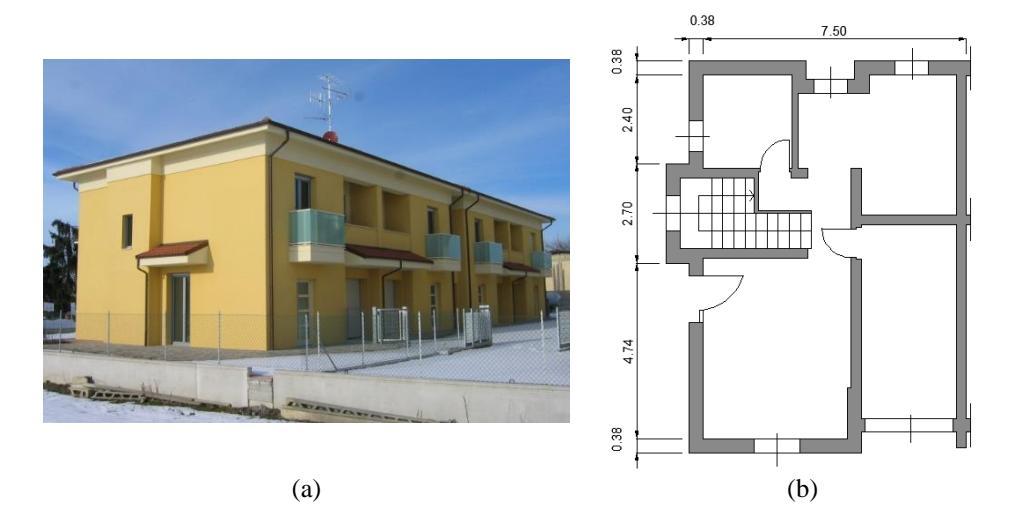
A detailed view of one of the two buildings, together with a sketch of the plan of one housing unit, is reported in Figure 16. As can be seen, the structure is characterized by an adequate amount of walls in the main directions (with a "wall density" ranging from 7 to 8%) and concrete ring beams were realized upon the walls. AAC bearing walls have a thickness of 360 mm and are covered by a plaster layer.

Figure 16 (a) Detail of one building belonging to the residential complex of Altedo; (b) 375 plan of the ground floor of one housing unit. 376

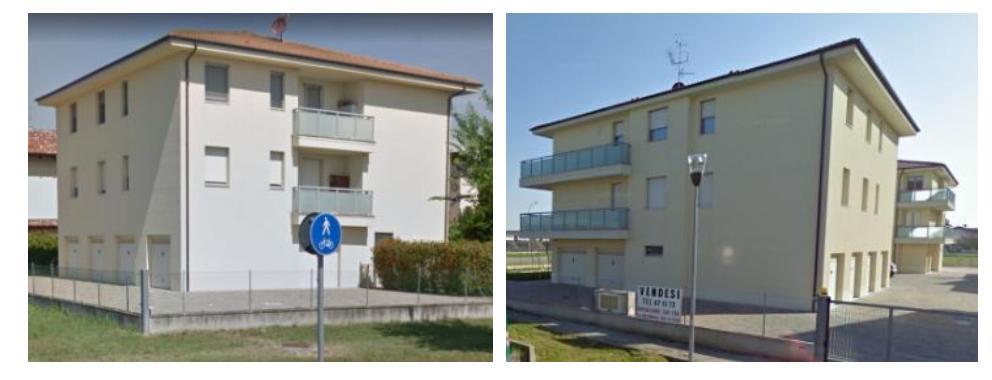
Figure 17 Residential complex made of unreinforced AAC masonry in San Pietro in 378 379 Casale (Bologna).

The second case study is represented by a residential complex made of a couple of three-storey buildings located in San Pietro in Casale (near Bologna), which undergone a 383 maximum PGA of 0.09g (Figure 5c). The buildings, depicted in Figure 17, were designed 384 according to seismic prescriptions, and were realized with 360 mm thick AAC seismic 385 blocks. The reference peak ground acceleration prescribed by the actual Italian Standard 386 Code for that area is 0.208g. No damages were detected during the post-earthquake 387 inspection survey, thanks to the substantially regular shape of the buildings, the use of 388 good quality materials and an adequate care in detailing. 389

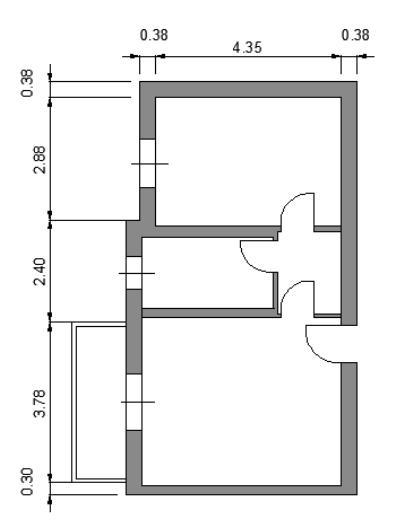
Figure 18 Plan of one apartment at the third level of the residential complex in San Pietroin Casale (Bologna).

The plan of one apartment placed at the third level of the residential building, shown in Figure 18, confirms also in this case the presence of an adequate amount of bearing masonry in the two main directions and the relatively small spacing between the bearing walls (lower than 7 m).

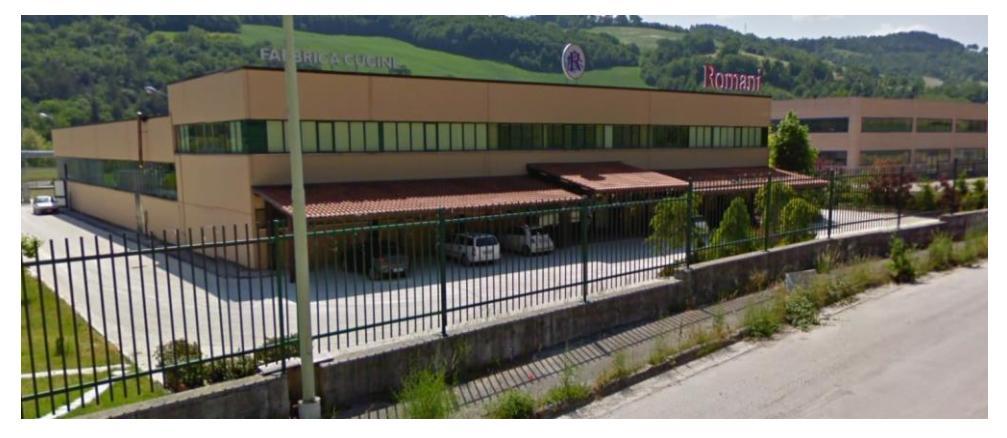
An interesting example where AAC was used for fire-resistant partitions is the furniture factory in Muccia (Macerata), shown in Figure 21. The internal view (Figure 22a) reveals a typical Italian precast concrete building, with prestressed concrete beams, precast thin-walled concrete roof elements (Belletti et al., 2016) and external panels.

**Figure 21** External view of the furniture factory in Muccia (Macerata).
