Influence of the laser ablation surface pre-treatment over the ageing resistance of metallic adhesively bonded joints

Influence of the laser ablation surface pre-treatment over the ageing resistance of metallic adhesively bonded joints / Moroni, F.; Musiari, F.; Favi, C.. - In: INTERNATIONAL JOURNAL OF ADHESION AND ADHESIVES. - ISSN 0143-7496. - (2020), p. 102764. [10.1016/j.ijadhadh.2020.102764]

# **Influence of the laser ablation surface pre-treatment over the ageing resistance of metallic adhesively bonded joints**

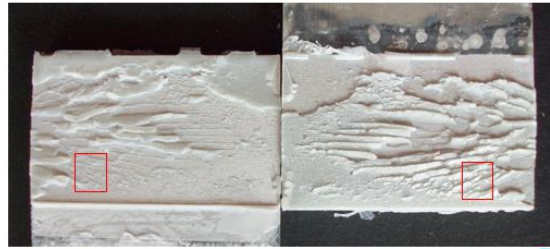
Figure 23 - SEM images of laser ablated ( $ED=0.51 \text{ J/mm}^2$ ,  $H=100 \mu\text{m}$ ) aluminum joint subjected to aging method C ((i) left side; (ii) right side), with magnified details (in the blue boxes).

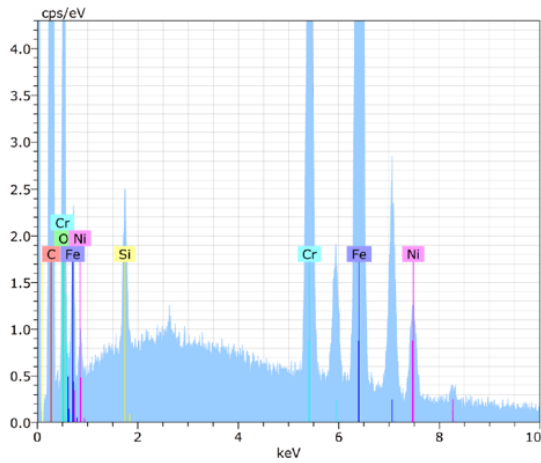
Figure 30 - Local EDX spectra measured on the areas A, B, C, respectively, of the surfaces shown in Figure 29
