Asphalt-based cold patches for repairing road potholes - An overview

Asphalt-based cold patches for repairing road potholes - An overview / Hafezzadeh, Raheb; Autelitano, Federico; Giuliani, Felice. - In: CONSTRUCTION AND BUILDING MATERIALS. - ISSN 0950-0618. - 306:(2021), pp. 124870.1-124870.19. [10.1016/j.conbuildmat.2021.124870]

# Asphalt-Based Cold Patches for Repairing Road Potholes- An Overview

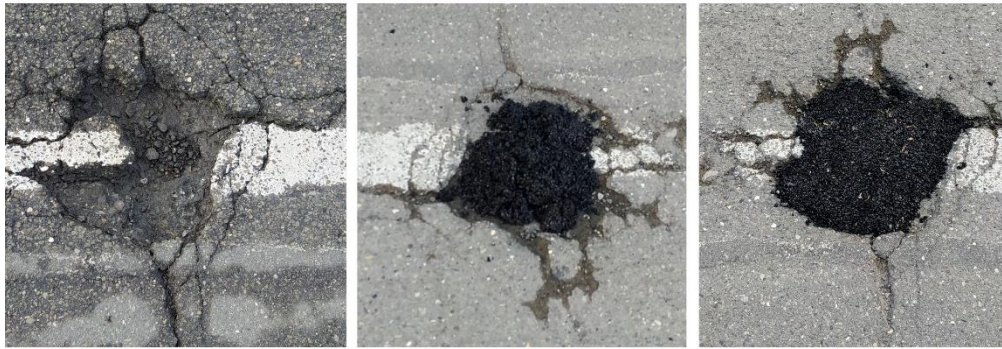
Figure 1. Patching a pothole with CPM

Road pavements deteriorate under various vehicle traffic and weather conditions. Thus, they need to be rehabilitated to restore serviceability [37]. This rehabilitation technique generally adopted for potholes is called patching (Fig. 1), which is the process of filling potholes in the road pavement with a suitable material to control further deterioration of the pavement and restore the users' safety and comfort [6].

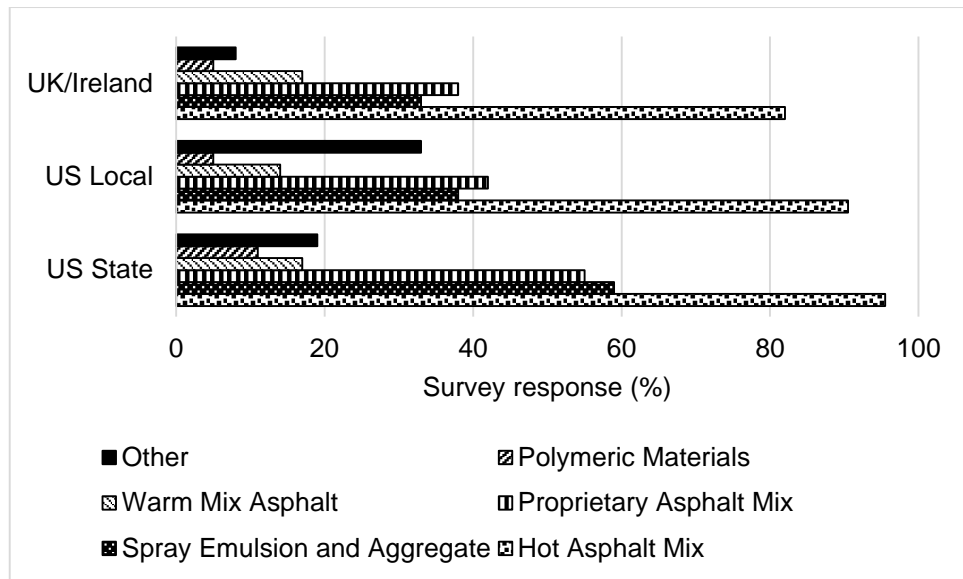
Figure 3. Materials used to repair potholes according to responses of agencies [42]

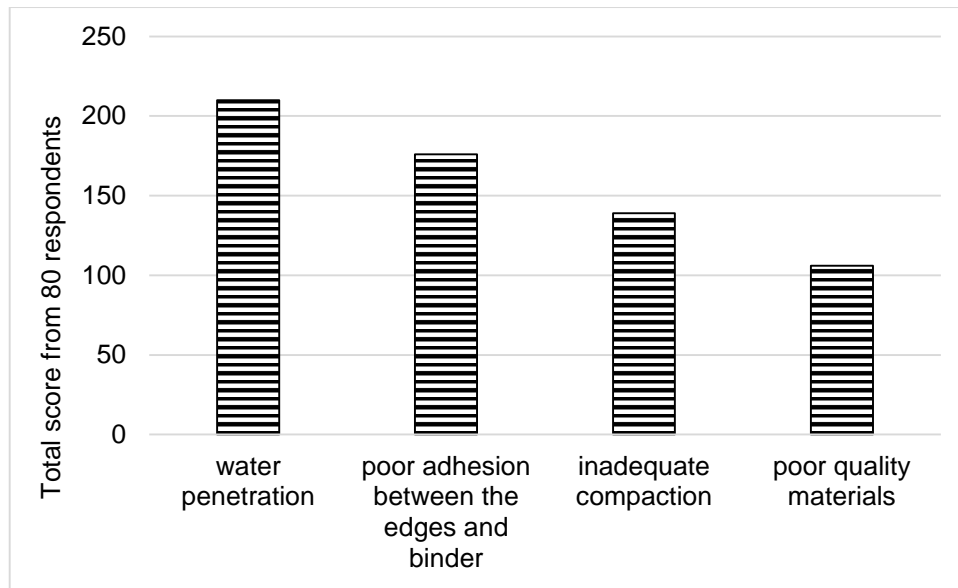
Figure 4. The main factor in failing of potholes in UK (least likely reason=1, most likely reason=4; the score is the sum of all weighted rank counts) [25]

325  
 326 Most of the symptoms and problems listed in the table, such as binder content, poor-graded  
 327 aggregates, and improper repair by the non-specialist crew, were also discussed by Kandhal  
 328 and Mellott [72]. However, depending on different circumstances, the impact of these factors  
 329 on patch failure can be different. The response of approximately 80 local authorities across the  
 330 UK to a questionnaire about the main causes of patch failure showed (Fig. 4) that water  
 331 infiltration and poor-quality mixtures have the highest and lowest impact on patch failure,  
 332 respectively [25].

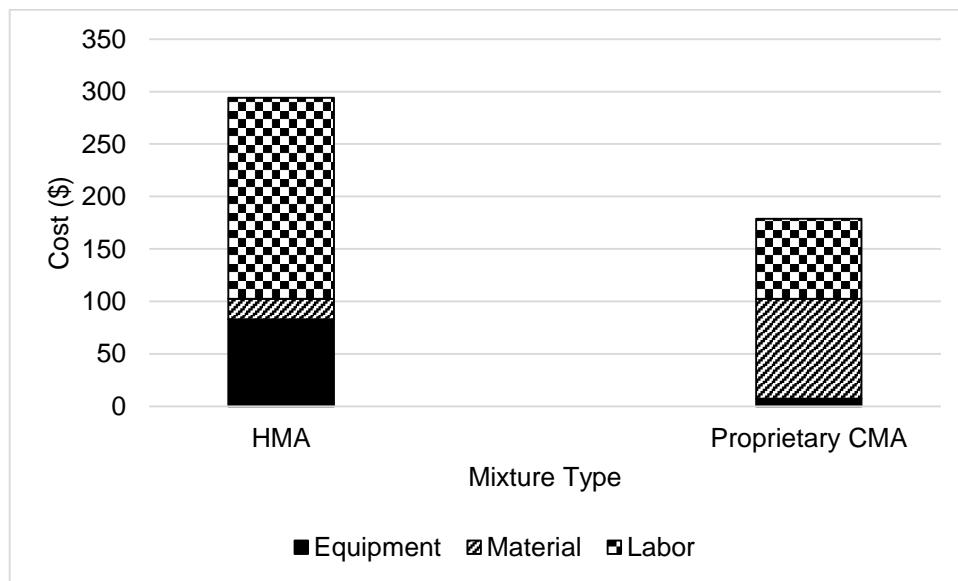
372  
 373 Figure 5. The comparison between devoted costs in 2015 for HMA and a proprietary CMA. (The  
 374 original cumulative costs were expressed in Euros) [73]

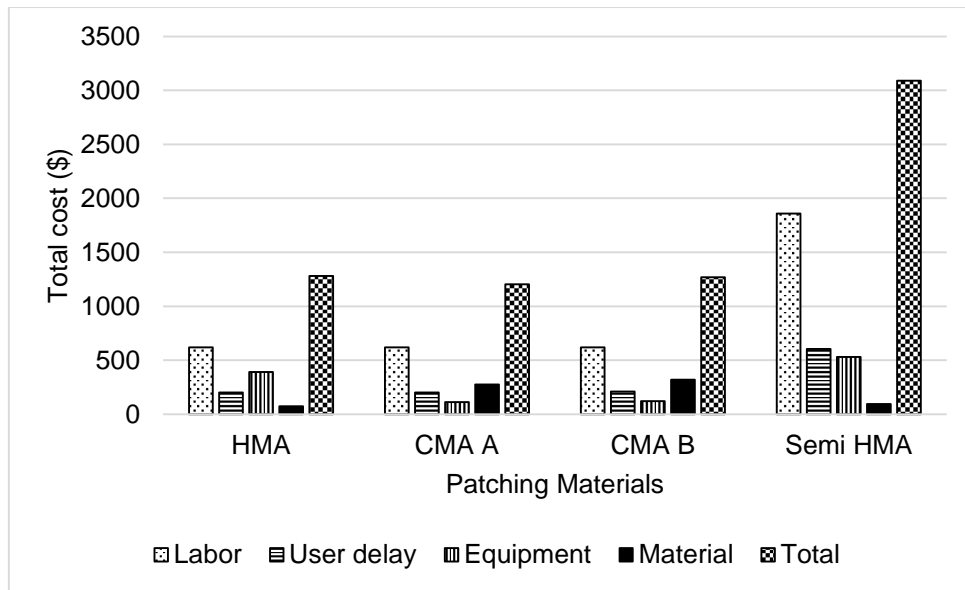
Figure 7. Total patching cost differences between cold mix and hot mix asphalt in 2014 [69]

13 416 cost for patching and traffic control can be considered as two and four workers for the throw-  
14 417 and-roll and permanent methods, respectively [37]. Confirming other similar studies, pothole  
15 418 repair using a semi-permanent method costs almost 2.5 times more than the throw-and-roll  
16 419 method [32]. These cost differences between throw-and-roll and semi-permanent methods have  
17 420 been shown in another study by Dong et al. [69] for Tennessee DOT. According to the results,  
18 421 repairing potholes with the various cold mixtures by the throw-and-roll technique requires  
19 422 much less cost for equipment and labor (Fig. 7).

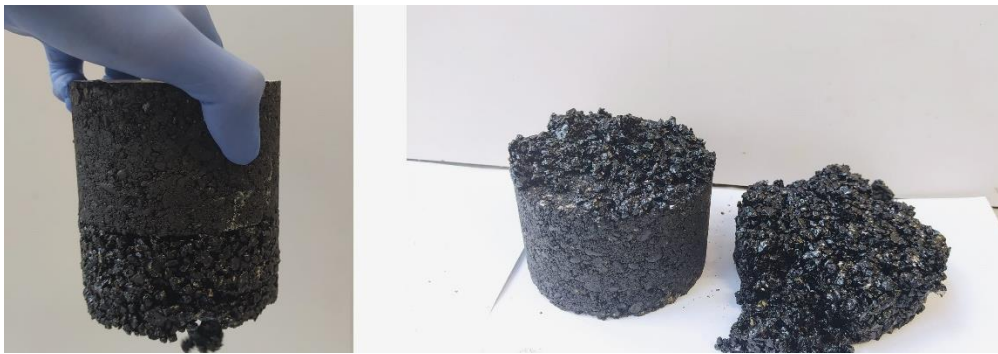
818  
819 Figure 9. Adhesion test on the inverted complex specimen

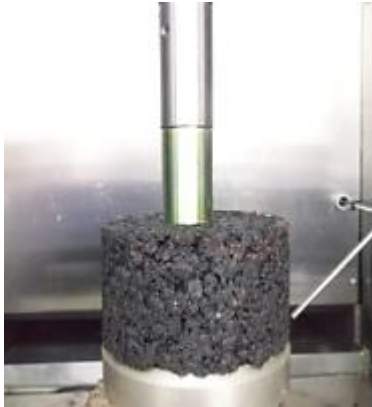
Figure 11. Conducting penetration shear test [87]

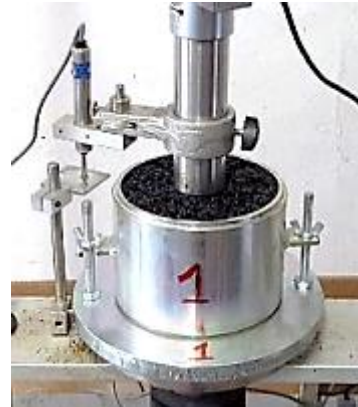
Figure 12. CBR test on cold patch mix [112]

study to assess CPM short-term premature deformation (Fig. 12). The results revealed that the CBR index is affected by the stone skeleton and aggregate gradation of the mixtures [112].
